## Collapse of the Grimburgwal, a historic quay in Amsterdam, the Netherlands

## Research Article

# Collapse of the Grimburgwal, a historic quay in Amsterdam, the Netherlands

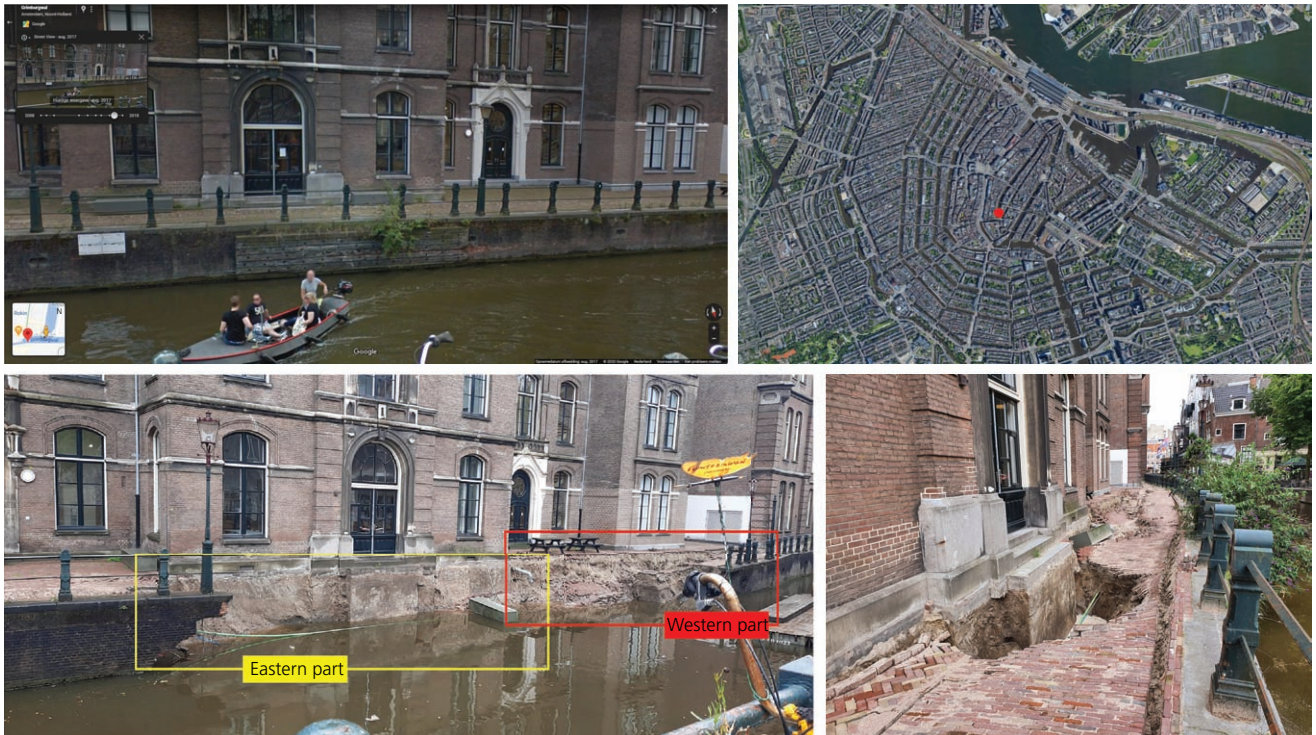
**Figure 1.** Collapsed quay and location in Amsterdam. Top left: initial condition of the quay in May 2019; picture from Google. © Google. Top right: location of GBW in Amsterdam at red dot. Bottom left: front view of quay just after collapse. Bottom right: surface view just before collapse

manoeuvre to turn and to steer into a narrow clearance under a historic bridge opposite of the failed quay. Signs of multiple ship collisions were found (see Figure 1). In old drawings, an older quay was found to cross the current quay near the site of the collapse. Also, the meteorological conditions just before the collapse were investigated. In 2014 the foundation of the building behind the quay was renewed. New piles were installed from the inside of the building. Interference with the foundation of the quay wall at the spot where the proximity of building and quay is closest could not be excluded.

observed that the depth of the canal increases in the direction of the bridge and then decreases again. The repeated collisions of the tour boats have weakened the quay. Ship traffic was a cause of masonry damage, which caused a precondition with less ability to distribute loads along the quay. The trigger for the collapse was believed to be the renewal of the pavement in May and August 2020. This repaving was necessary as a result of the deformation of the quay that occurred before. The effects of this repavement were clearly recognisable in the satellite measurements that show an increased settlement rate over time during repaving. Groundwater flow and drought/rain may also have played a role in accelerating the failure in combination with the horizontal quay deformation that had already occurred and the leakage path from behind the quay towards the canal for the formation of holes in the pavement as shown in Figure 1.

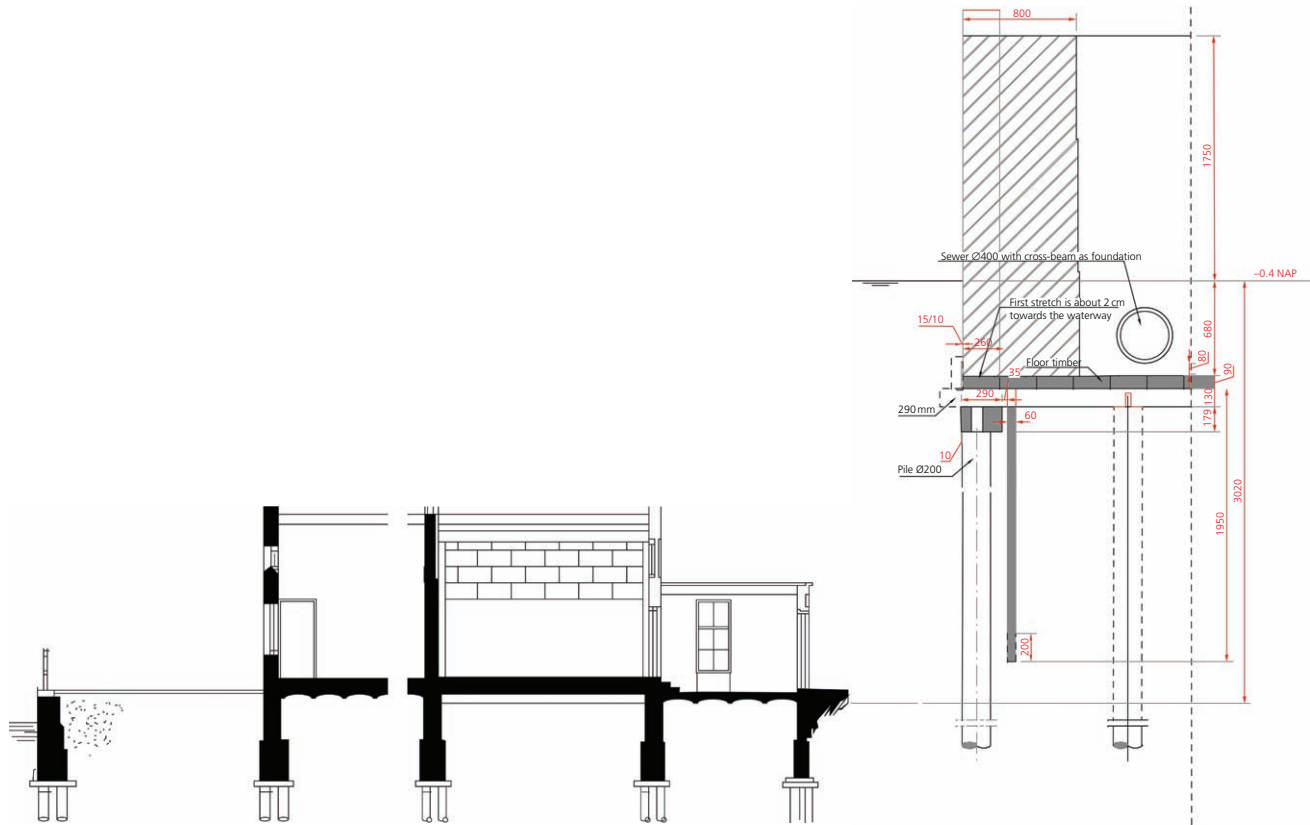
**Figure 2.** Cross-section of the quay wall according to historic evidence (the quay was built around 1875) on the left, and cross-section according to divers' inspection with dimensions on the right (dimensions are in mm). NAP, Amsterdam Ordnance Datum

The main failure mechanism was the horizontal bending of the piles as a result of a local deepening of the canal followed by breaking of the quay piles. This explanation assumes that only two rows of piles were present or functioned effectively over at least part of the quay. This is in accordance with the historic evidence and the underwater inspection and is also the most likely given the very short distance from the quay to the building behind it, where there is not enough space for a system with three piles. The long-existing cracks in the masonry wall reduced the possibility of redistribution of forces in the quay in the longitudinal direction, so that the loads could no longer be transferred to the stronger parts (with three rows of piles). The analyses were carried out with the assumption that the timber was not degraded, which to date needs to be confirmed. The presence

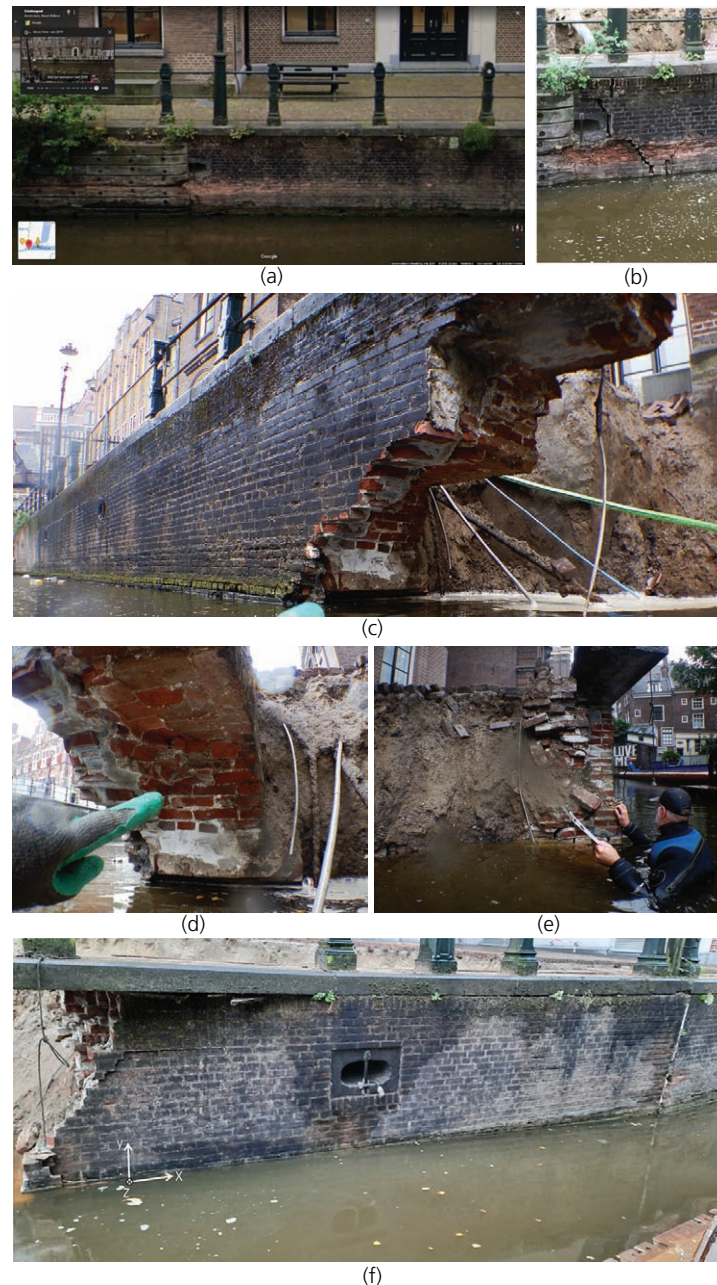
A detailed assessment of the cracks (see Figure 7 for the crack locations and identification) was made. The middle crack (crack ref. 2) was clearly visible a few minutes before the collapse of the structure (Figure 3(b)). The crack was located in an area subject to extensive damage due to mainly boat impacts, opened and deformed out of plane. The latter can be related to actions of the soil laterally pushing the quay wall. It is not clear if the crack already existed before the collapse of the quay wall started.

On the eastern side of the collapsed quay wall, a regular diagonal/vertical crack (crack ref. 3) was observed (Figure 3(c)). The surface shows an identical shape along the entire thickness of the quay wall. This indicates that out-of-plane torsional actions are to be excluded. The eastern crack is vertical on the top part of the quay wall. To obtain this pattern, a deformation along the quay wall was required. This deformation can be triggered by an in-plane rotation of the

failed part of the quay wall. The eastern crack shows a sequence of horizontal and diagonal sections just below the top part of the quay wall. To form such a pattern, a deformation along the vertical direction was required. This deformation can be triggered by an in-plane rotation of the failed part of the quay wall and/or an in-plane vertical collapse of the failed part of the quay wall.

Pictures available in Figures 3(c) and 3(d) indicate that the failure occurred in a restricted time span, as all cracks, excluding the previously described existing cracks, are fresh. However, damage due to environmental conditions at the waterline, which can also be seen in these pictures, can be a sign of earlier deterioration of the material.

On the western side of the collapsed quay wall, a diagonal/vertical crack was observed, indicated as ref. 1 in Figure 7 and in detail shown in Figure 3(e). The surface shows an irregular shape along the thickness of the quay wall, including the opening of vertical joints in the thickness. This indicates that out-of-plane torsional actions occurred in this section. Considering the out-of-plane deformation of the remaining part observed at the front side of the quay wall (Figure 3(e)), it is possible that the collapsed western part failed due to out-of-plane torsional actions and out-of-plane overturning action. From the overview, it is possible to observe that the remaining part of the quay wall shows a residual

**Figure 3.** Cracks in the quay. (a) Ship collision crack ref. 2 from Google 1 year before collapse. © Google. (b) Crack B visible minutes before the collapse. (c) Eastern crack ref. 3 after collapse. (d) Eastern crack ref. 3 detail with sharp surface in bricks. (e) Western crack C after collapse. (f) Front view of western crack ref. 1 left and dilation joint ref. 5 on the right

vertical deformation. This deformation can be triggered by an in-plane rotation of the failed part of the quay wall and/or an in-plane vertical collapse of the failed part of the quay wall.

Furthermore, Figure 3(f) on the right shows a dilatation joint (ref. 5) with an opening without the presence of out-of-plane deformations. This potential in-plane deformation is compatible with the vertical residual deformation recorded for the remaining part of the quay wall. Lastly, a tapered crack (crack ref. 4) cuts through the quay wall on the

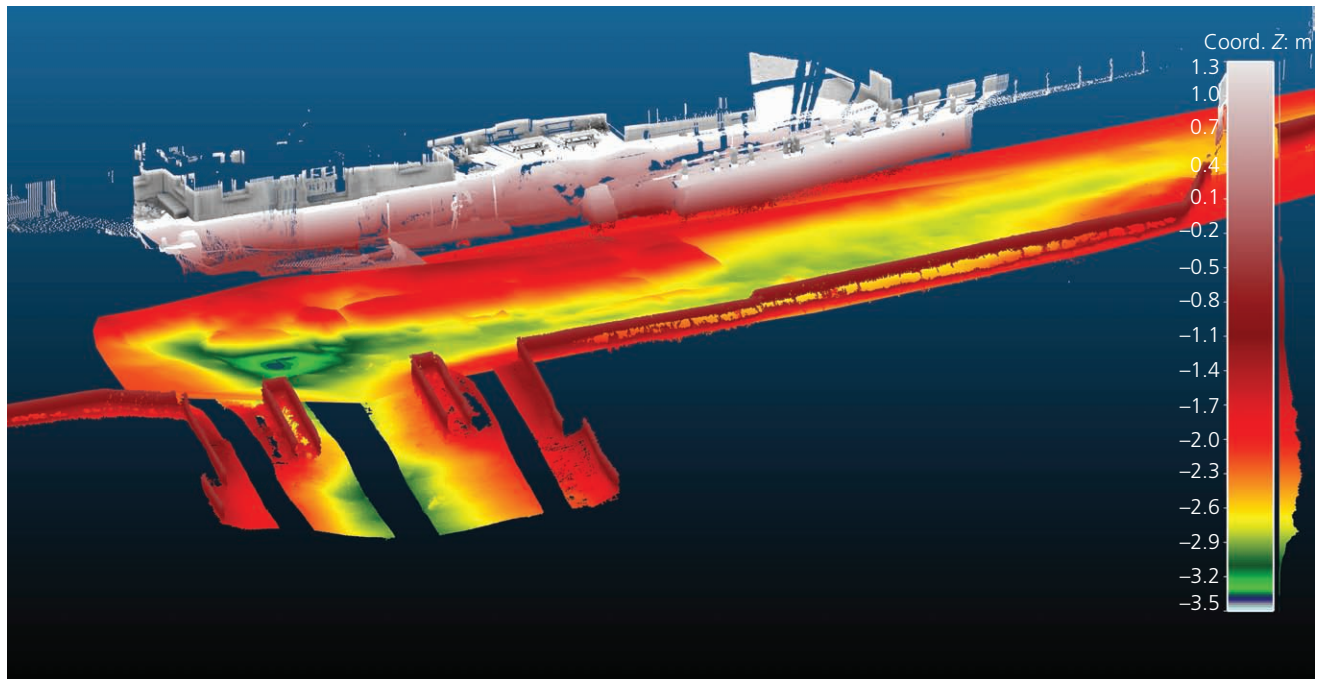
**Figure 4.** Visualisation of the multibeam and three-dimensional scan made after collapse of the quay by Van Gellecum (2021). The colour red refers to shallow bed levels, showing debris in canal and quays and bridge foundations opposite of collapsed stretch, and colours green to blue refer to the deepest canal bed level (NAP  $-3.25$  m and locally to NAP  $-3.5$  m)

The cause of the deeper canal bed is likely related to the fact that the canal is very narrow at this location and exactly at this spot the four boats turn sharply under a bridge. It has been

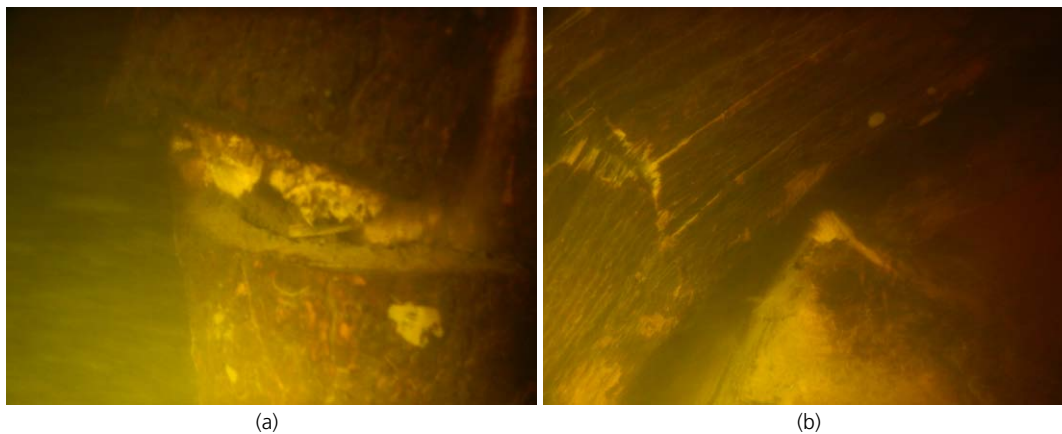
**Figure 5.** Pictures of the collapsed foundation under water by Van Gellecum (2021): (a) broken pile; (b) broken cross-beam

From Figure 11, it can be seen that for the two-row pile system, the bending stress in both pile rows exceeded the timber capacity (in green) for the smaller piles even for small increases in canal bed depths. For larger pile diameters, this was not the case nor for quays with three pile rows. Comparing the results of the bending of the piles with the initial horizontal movement of the quay as seen in Figure 1 and the deformations of the satellite measurements in Figure 6, as well as the broken foundation parts in Figure 5, leads to a consistent collapse mechanism.

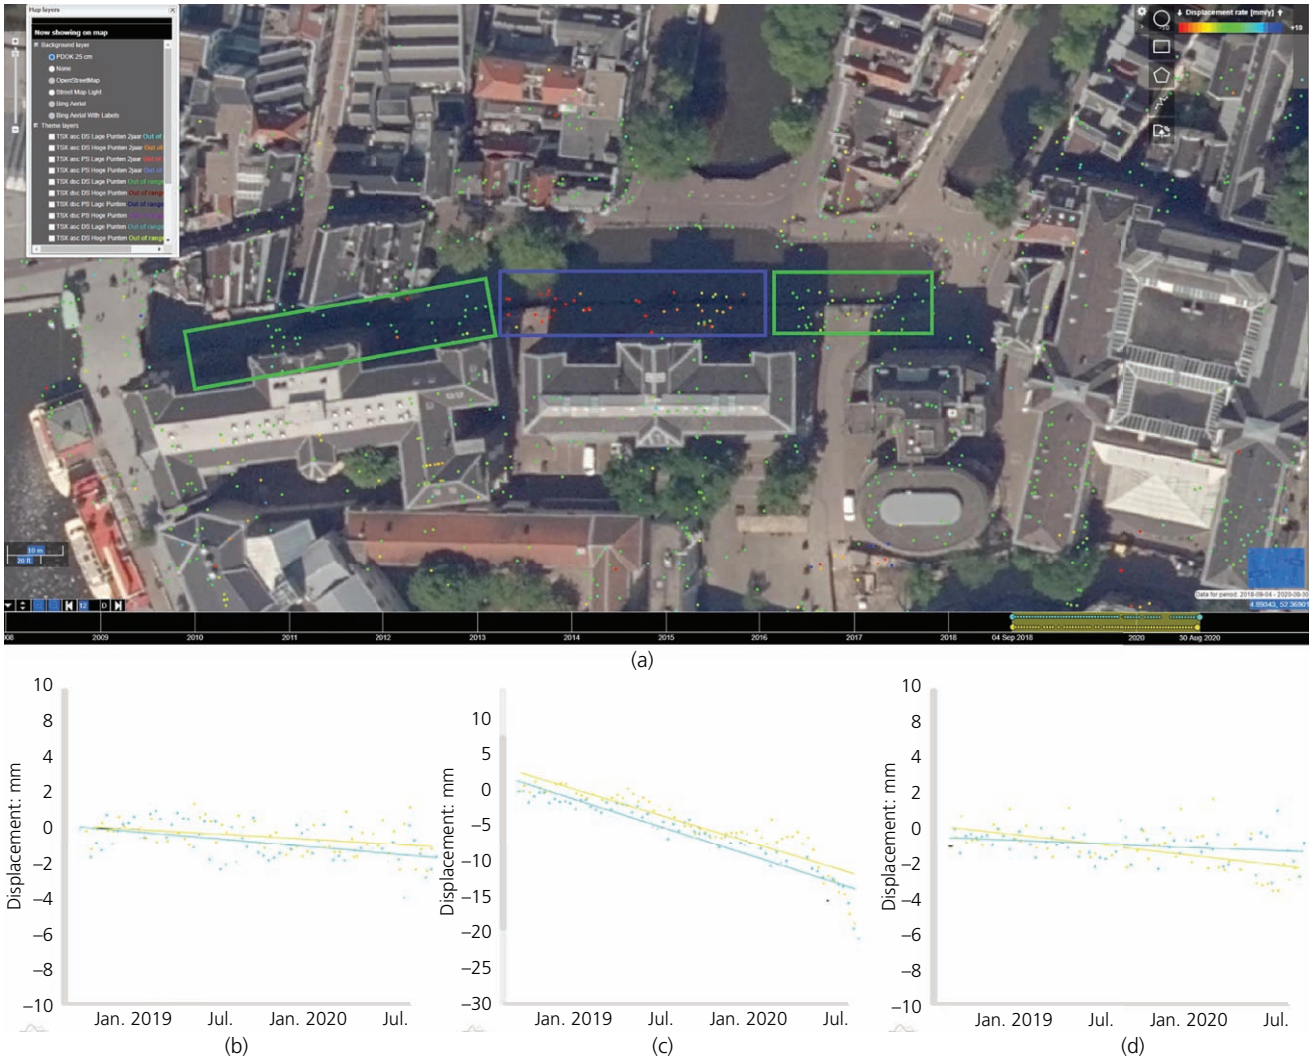
**Figure 6.** Satellite measurements with (a) overview of settlement reflection points over the 2 years before the collapse on a scale of  $-10$  mm in red to  $+10$  mm in blue. (b, d) Settlement point average of the zones on either side of the collapse in green rectangles in (a) and (c) settlement point average of the collapsed section in blue rectangle in (a); results from both ascending (yellow) and descending (blue) tracks are shown

Furthermore, it was found that interferometric synthetic aperture radar (InSar) measurements provided a good insight into the weakness of the quay wall section, as it was possible to identify deviating settlements of the street behind the quay already long before the collapse. The vertical settlements are a result of horizontal deformation of the quay, an indicator of possible collapse. It is thus possible to use InSar in the stress testing of quay walls and to reduce the risk of collapse by paying systematic attention to settlements behind the quays. Analysis of the subsidence of the quays with InSar measurements can help map other 'hotspots'. Additionally, a registration/notification system can be set up for the occurrence of subsidence on the quays or necessary street work. Also, it is advised to perform measurements of the quays (preferably not only horizontally on the quays but also vertically) and to investigate the relationship between the deformation and possible failure (numerical or experimental). Further analyses must be performed to determine which limit values indicate failure.

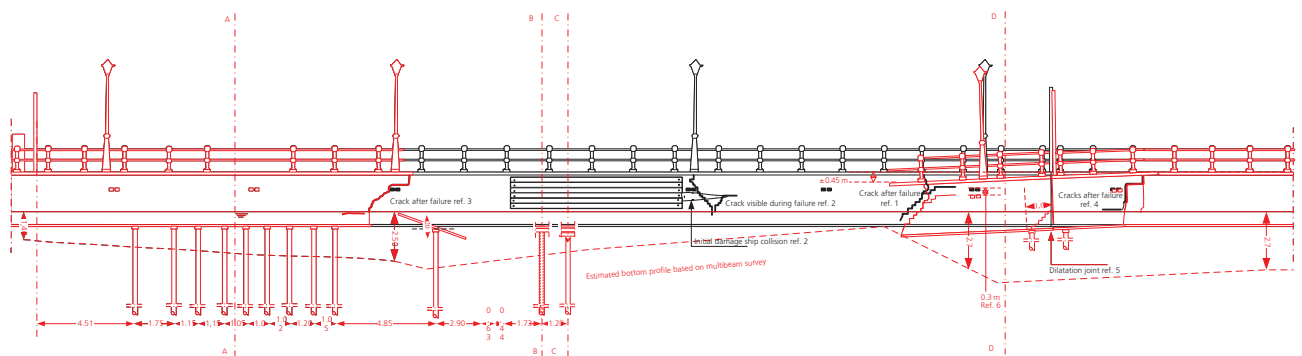
most western part. This crack is consistent with the vertical residual deformation recorded for the remaining part of the quay wall.

**Figure 7.** Front view of the wall. In black, the situation prior to collapse; in red, the situation found after collapse, including crack locations (dimensions are in m). East is on the left; west is on the right

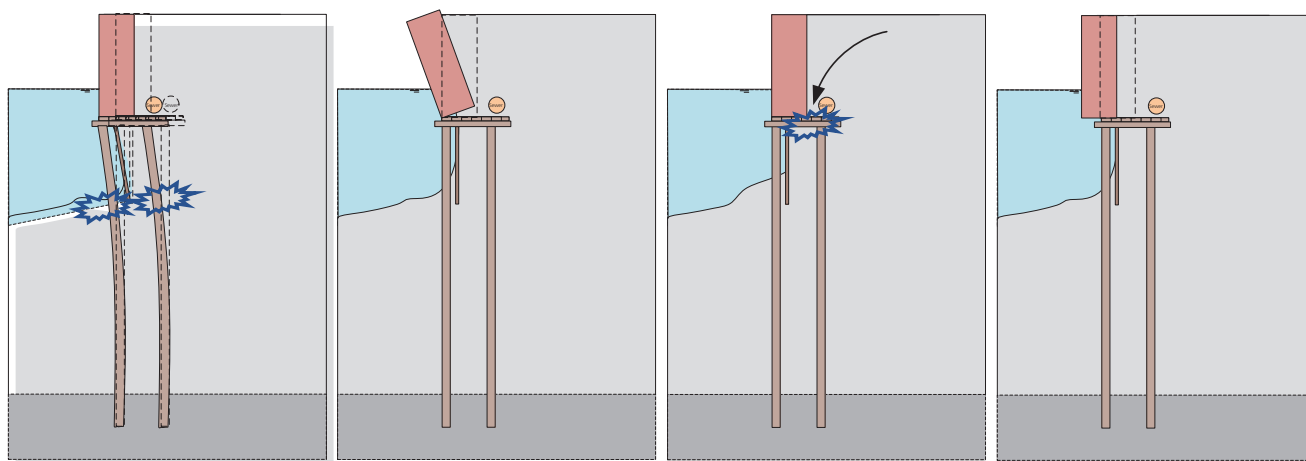
Some of the most important mechanisms are shown in Figure 9 and can be found in general sense in, for example, the handbook *Quay Walls* (De Gijt and Broeken, 2013) or the Dutch handbook of inner-city quay walls (Roubos and Grotegoed, 2014). From left to right, Figure 9 shows the horizontal bending of the piles and local geotechnical failure of soil around the piles, the overturning

of the masonry wall, cross-beam failure and horizontal sliding of the masonry from the deck. Other failure mechanisms investigated include the axial capacity of the foundation piles and the structural failure of the masonry wall.

Figure 9. Most relevant failure mechanisms for the quay wall from left to right: horizontal bending of the piles and local geotechnical failure of soil around the piles, overturning of the masonry wall, cross-beam failure and horizontal sliding of the masonry from the deck

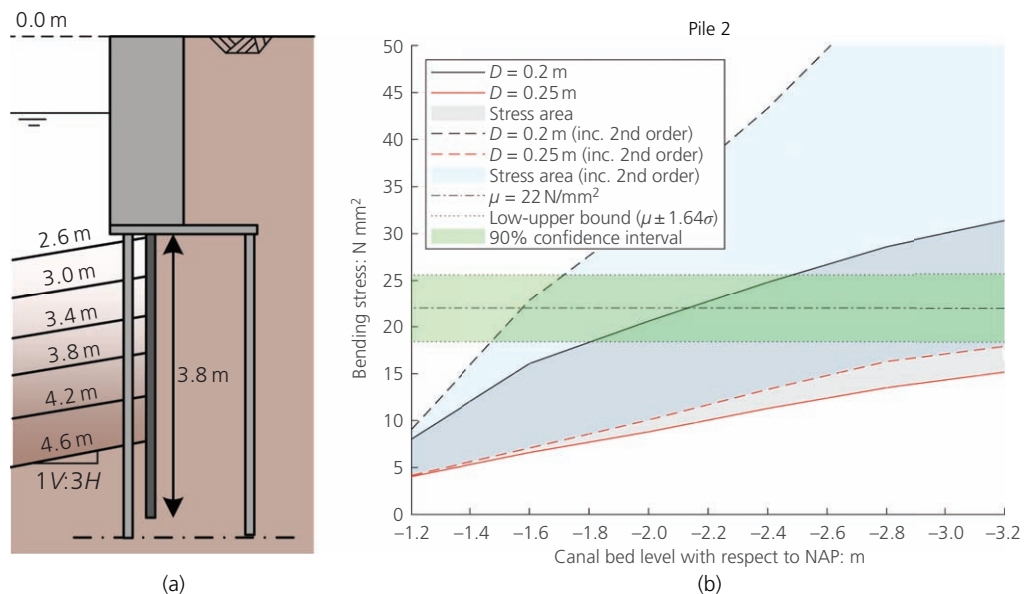
Figure 11. Results of the bending stress in the piles (a) depending on the depth of the canal and (b) for different pile diameters, first- and second-order calculations and strength of the timber

This assessment has shown that the geometry of the quay played an important role in the sensitivity of the quay to the deepening of the canal. This resulted in measures/follow-up actions being recommended related to stress testing the historic quays in Amsterdam. The main recommendations are to check other places with soil erosion of the canal bottom, quays that have only two rows of piles as foundation and/or quays with damage of the masonry in the form of cracks.
