AIAA SCITECH 2022 Forum

Re engineering history: Flight of the Phoenix, what can we learn from a movie crash?

Michiel J. Schuurman*, Roeland De Breuker[†] and Christos Kassapoglou[‡]
Delft University of Technology, Faculty of Aerospace Engineering, Delft, 2629HS, The Netherlands

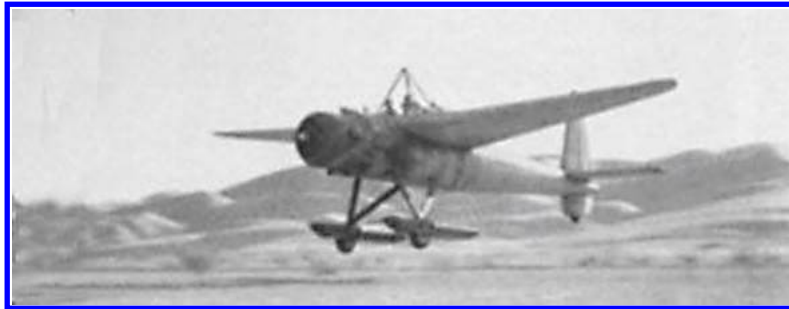
Fig. 2 Tallmantz P-1 flying for the Flight of the Phoenix movie sequence [23].

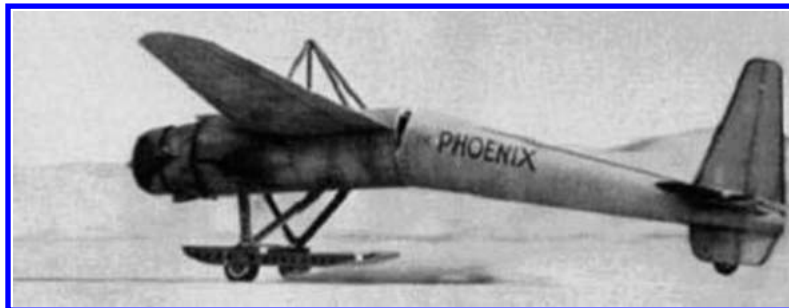
A final third pass was made in which the P-1 touched down on the sand. Bobby Rose escaped from the wreckage with a shoulder injury and Paul Mantz was fatally injured.

Fig. 3 Tallmantz P-1 side view of the tail section separation during 3rd pass in front of the camera's [23].

The pilot's first two passes over the flight course were too high, and he flew the third pass at a lower altitude and slower airspeed. As he approached the cameras he was advised the third pass "looked good," and it was continued. Shortly thereafter, the aircraft touched down relatively hard and in a level flight attitude about 200 ft. northeast of the eastern-most camera. After a roll of about 24 ft. the aircraft struck a small rise of soft sand which caused it to bounce about 3 ft. above the ground. At this time the wood-fabricated aft section of the fuselage was observed to separate from the metal forward section at the two top longeron wood-to-steel longeron attachment fittings.

Examinations by aeronautical and aerospace engineers of the steel-to-wood fuselage longeron fittings, where the failure occurred, showed the design and fabrication of the fittings were in accordance with good aeronautical engineering practice. They concluded that the wood longerons failed in tension due to overloads. The 60-lb. lead weight in the tail section was concluded to have contributed directly to the overload, as did the drag force transmitted to the fuselage by the landing gear when the wheels struck the rise of soft sand. The previous hard landing was considered to have possibly contributed to the failure.

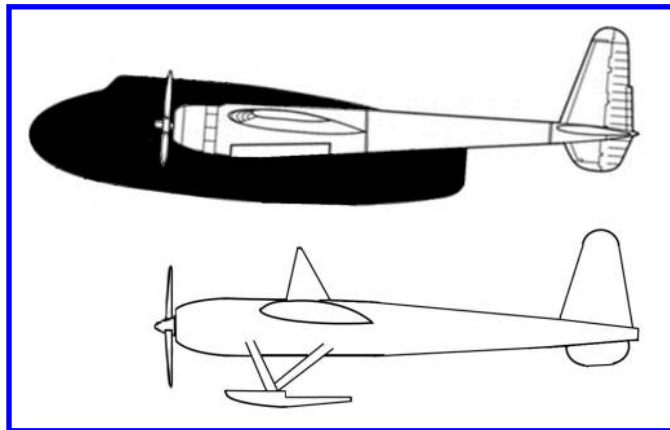
The 3-view drawing that was included with the experimental certification documentation a general layout of the Phoenix is given. However, some measurements do not match with design specifications. As an example, the overall length of the Tallmantz P-1 is given as $42\frac{1}{2}$ feet. However, the three chain dimension on the same drawing add up to a total length of 40 feet. According to the FAA certification document the P-1 was equipped with a Hamilton Standard constant speed propeller. It is known and very likely that the propeller and engine (Pratt & Whitney R-1340 Wasp) combination were used from the T-6. The propeller diameter for the T-6 is 9 feet [26]. However, the propeller diameter in the 3-view drawing is shown as 11 feet. Further examination of Tallmantz P-1 photographs before and after the event show a different number of holes in the skids and struts compared to the 3-view drawing. Accident photos also show that the number of holes on the landing brace structure do not correspond with the 3-view drawing. Therefore, the validity of the 3-view drawing in the FAA certification documentation cannot be verified. Assuming that Otto Timm took the C-82 tail boom assembly outline as reference for the P-1 design. He would have tried to create an airplane which, for the camera could resemble the C-82 tail boom. The C-82 tail boom shape is a slender circular section which after the wing narrows to the rudder and tail section. In order to resemble the C-82 the P-1 should have a shoulder wing design. Examining the P-1 empennage section there is a ventral fin. Ventral fins are included to improve directional stability and enhance spin characteristics and recovery. It is unlikely that it would be necessary to increase the vertical tail surface area given the fact there is already a substantial rudder. Furthermore the P-1 was not designed to be a (trainer) aircraft where spins are allowed.

Fig. 4 Top view contour drawing Fairchild C-82 Packet with the left tail-boom in white (left) and the Tallmantz P-1 "the Phoenix" outline (right).

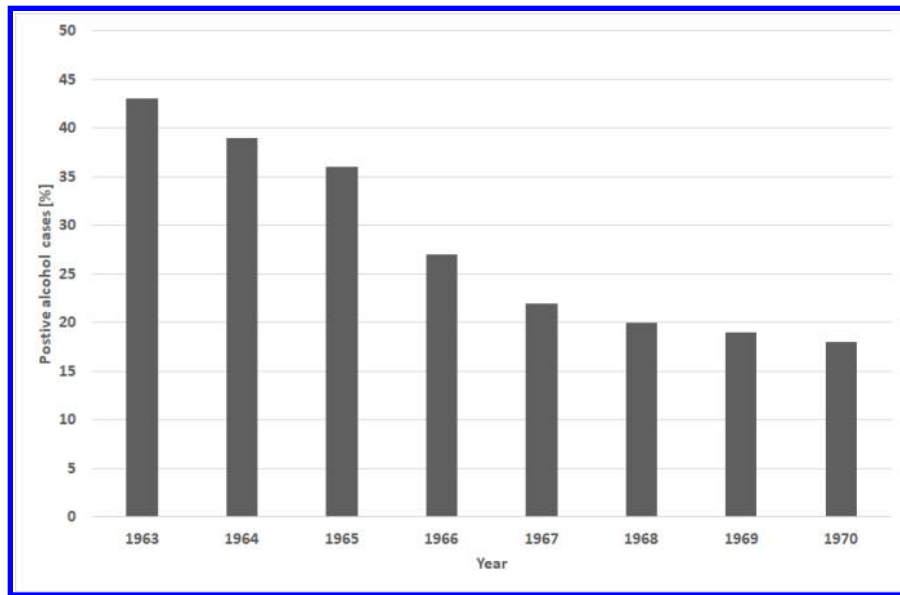
Fig. 6 General Aviation positive alcohol cases [%] [27]

Reviewing the general aviation accidents from 1963-1970 it is evident that alcohol was present in many accidents, see Figure 6. In a 1963 study a total of 35.4% pilots involved in general aviation accidents had measurable level of alcohol in their blood at the time of their crash [30]. This study however did not account for contamination of the blood and putrefaction. Subsequent studies which accounted for contamination revealed lower values [31][32][33]. Especially in case of extensive (abdominal) trauma, which is very likely in aviation disasters (e.g. rupture of the viscera), interpretation of blood alcohol values in autopsy specimens from the pilot and crew is highly contentious [34]. In recent studies the main conclusion is that care must be taken to reach a valid conclusion related to blood alcohol levels.
