PRESERVING THE PAST, ENERGIZING THE FUTURE

*ASSESSING THE INTERPLAY OF INTERVENTION STRATEGIES ON HERITAGE
VALUE AND ENERGY EFFICIENCY*

AR3AH105 Graduation Studio
Adapting 20th Century Heritage

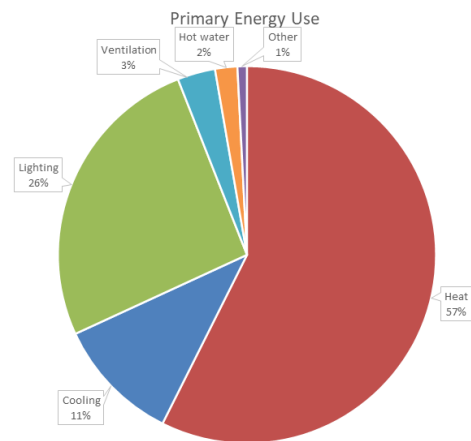
Graph 1. (Primary Energy use of Call center (Own image, 2023))

By then placing these values in a Excel graph (per month), the operational energy becomes visually clear. The results show that currently most energy is needed for heating and cooling the building, mainly due to the low insulation in the buildings envelope and the low U-values of the windows. It was found that the energy consumption is currently 253 kWh/m², which is insufficient and means that the building has an energy label of D. The total operational energy per square meters would then be 889.2 MJ/year/m², which leads to a total of 1.978.470 MJ/year. Chapter 3.5 will determine what strategy can be applied to improve the operational energy of the building.

As we can see, the operational energy consumption of the property is currently too high. This makes sense, as shown in the study by Van Krugten et al. (2016), which shows that historical properties before 1970 generally have lower energy efficiency than properties after 1970. The aspiration could be, to be able to achieve an energy label A for the property. This would require a maximum energy consumption of 100 kWh/m² per year (Ministry of General Affairs, 2022).

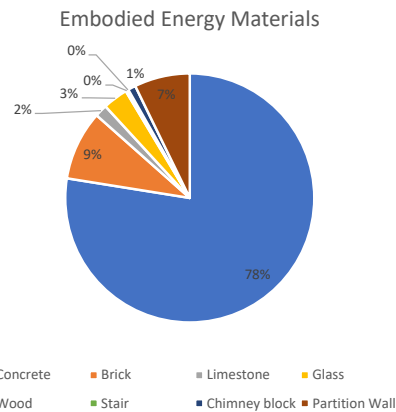
Graph 3. Ratio of EE in Call Center (own image, 2023)

By then multiplying the volumes of the materials with the Embodied Energy [MJ/m³] number belonging to the material, the total amount of Embodied Energy [MJ] can be calculated. The first number has been derived from the

Materials such as limestone, glass, and the wood of the window frames contain much less embodied energy. Therefore, should a strategy for replacing these materials be chosen, the amount of embodied energy does not prevent this operation from being carried out.

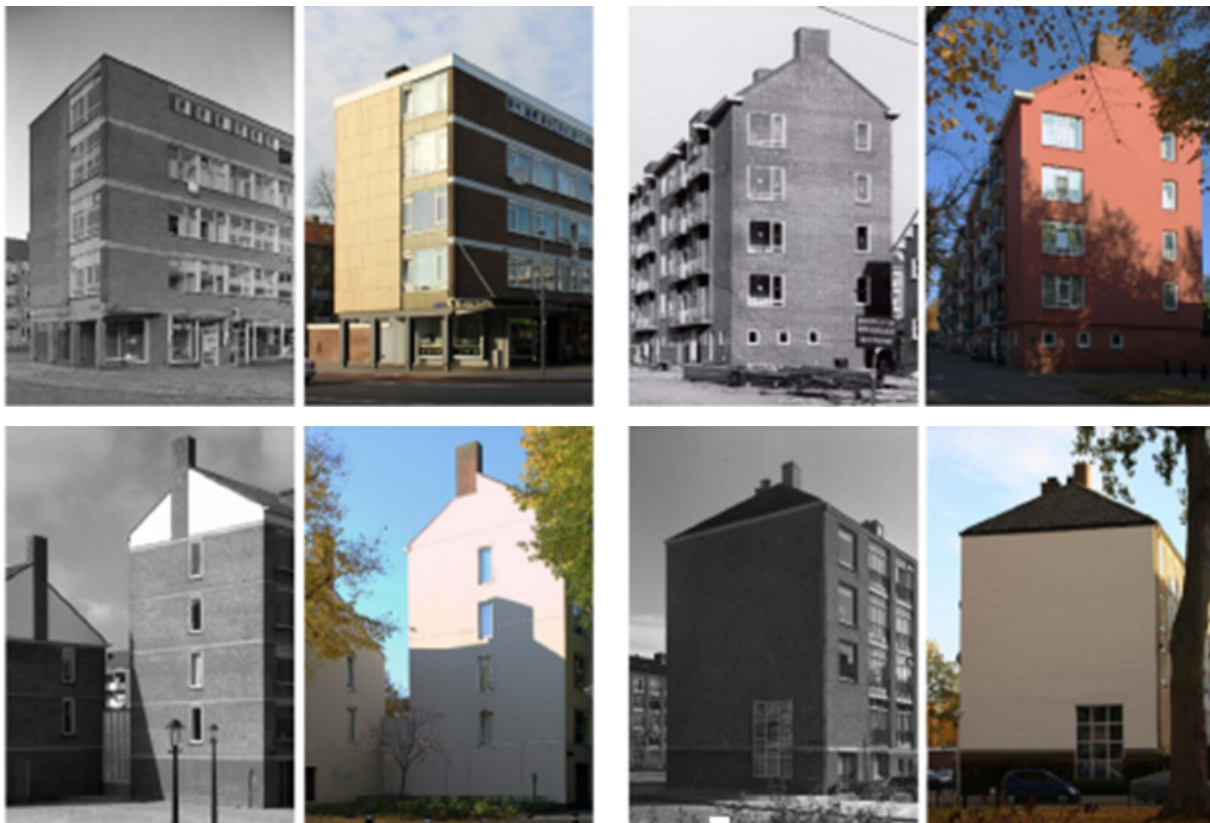
done in several ways. Firstly, insulation materials can be placed on the outside of the façade. By doing this, there is a change a heritage building loses some aesthetic & age-related values (Pereira Da Silva and Pereira Roders, 2012). This becomes clear in the study of by Havinga et al. (2020). The study shows that this method has often been applied in post-war neighbourhoods. A conclusion was that the insulation did cover up the masonry of the original facade. Therefore this strategy was assessed as a negative strategy to reduce the operational energy since it decreased the heritage value of the buildings.

Fig 10. Different buildings where insulation is applied on the outside of the facade, losing the sight of the masonry (Havinga et al., 2020)

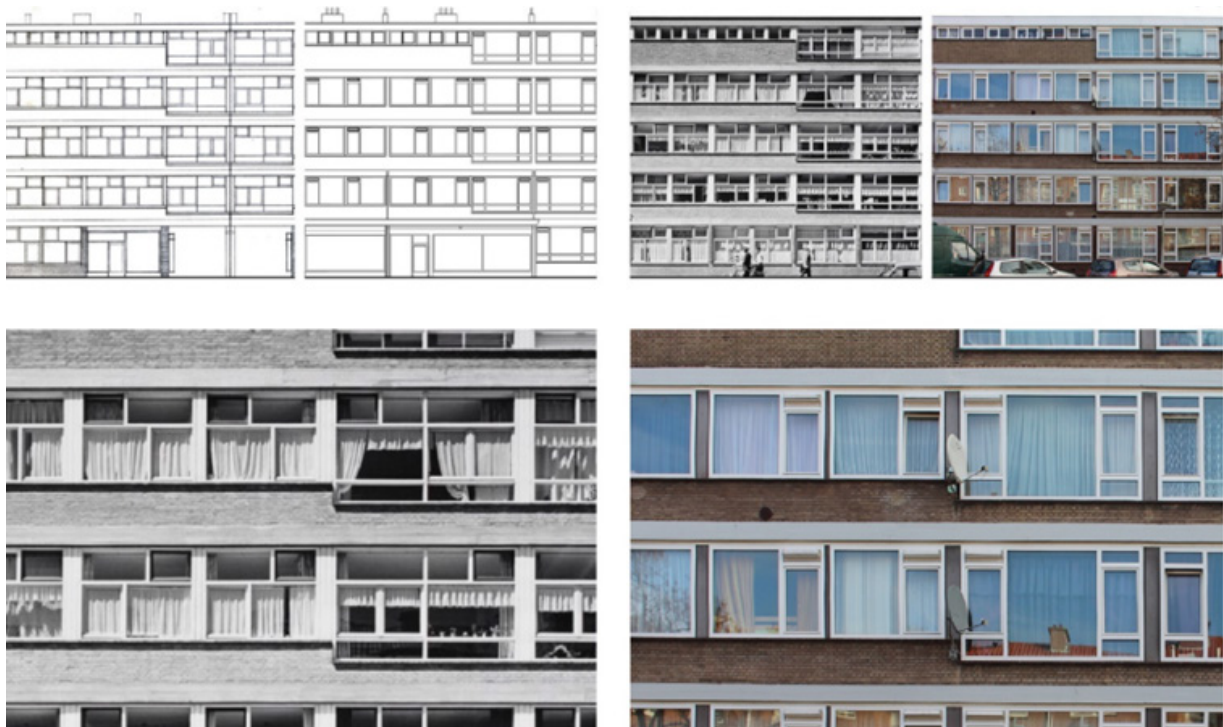
However, caution is warranted in the execution of such interventions, as evidenced by the findings of Havinga et al. (2020). Their academic report delves into the heritage attributes of post-war housing estates in Amsterdam, revealing a notable loss of value associated with window frame replacements. The study identifies the replacement of window frames as one of the most negatively perceived interventions. In many instances,

Fig 12. Replacement of window frames without considering the heritage value of the former frames (Havinga et al., 2020)

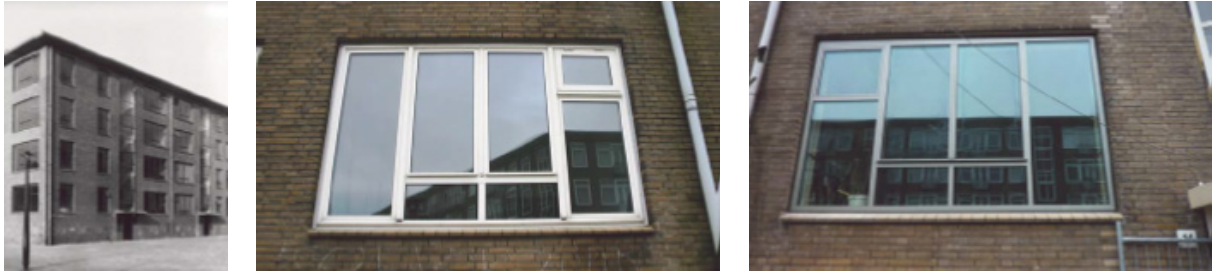
The latter was also the case with the 'De Koningsvrouwen van Landslust' project; the original building dates from 1938 and was characterized, among other things, by its steel window frames. These were replaced by white aluminum window frames in 1980. However, this affected the historical and aesthetic values of the facade. In the more recent renovations in 2011, the facade was restored to the millimeter (Wind, 2011). New aluminum window frames are now similar in aesthetic appearance to the original steel window frames

Fig 13. Change of window frames at the project 'Koningsvrouwen van Landlust'

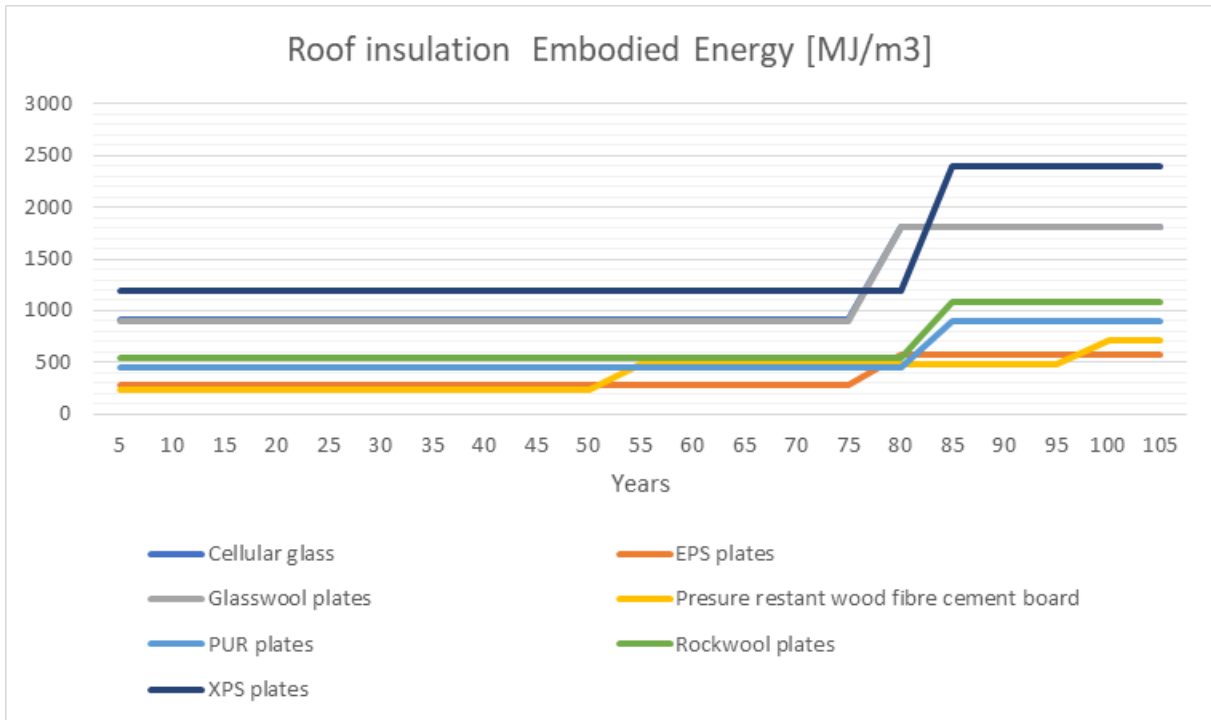
Graph 8. Embodied energy of insulation materials used for the roof

In addition to the facade, floors and roofs are often insufficiently insulated in heritage buildings (Akande et al., 2014) (Koezjakov et al., 2018). Furthermore, the analysis of the case study revealed that the insulation here is also inadequate for a new function. The addition of new roof insulation is therefore a requirement. For this reason, research has also been conducted on the amount of embodied energy in various roof insulation materials. The results are again shown in the graph below, which shows that two materials have significantly higher embodied energy values than the rest: XPS and glass wool boards. As a

result, it can be concluded that these are less sustainable choices compared to the other materials. Indeed, all other materials show relatively low scores in terms of their embodied energy. However, when we look at the thermal conductivity of the materials and calculate how much volume of the material is actually needed to achieve an acceptable Rc value in the design case, it appears that cellular glass seems to be the least responsible choice. This calculation also shows that EPS boards and the pressure-resistant wood fibreboard are the most durable materials, followed by PUR boards.

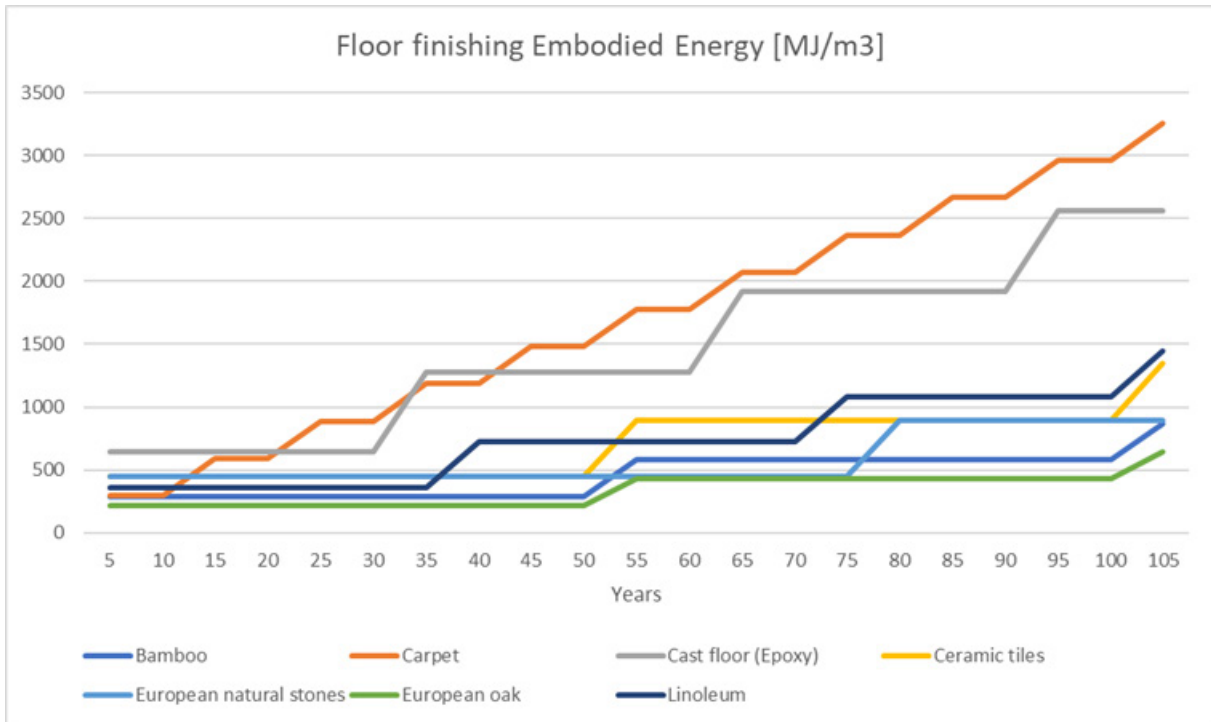
Graph 10. Embodied energy of floor finishing materials

Besides the insulation of the floor, its finish also has a significant impact on the amount of embodied energy, this becomes clear from the chart of results. It appears that choosing carpet as a floor finish has a significant impact on embodied energy in the long term, as this material has a limited lifespan and needs to be replaced every 20 years. On the other hand, using oak flooring is a significantly more sustainable

choice, due to the longer lifespan of the material and the initial amount of embodied energy
