Field Measurements of Very Oblique Wave Run-up and Overtopping with Laser Scanners

Oosterlo, P., Hofland, B., van der Meer, J. W., Overduin, M., & Steendam, G. J. (2020). *Field Measurements of Very Oblique Wave Run-up and Overtopping with Laser Scanners*. 1-2. Abstract from ICCE 2020: International Conference on Coastal Engineering (Virtual). <https://doi.org/10.9753/icce.v36v.waves.20>

FIELD MEASUREMENTS OF VERY OBLIQUE WAVE RUN-UP AND OVERTOPPING WITH LASER SCANNERS

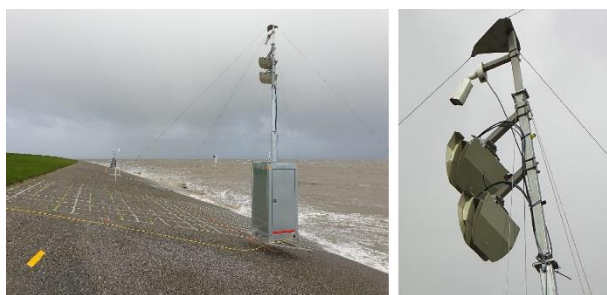
Figure 2 - Left: New laser scanner system next to the overtopping tanks on the dike in the Eems-Dollard estuary. Right: from the bottom to the top: Laser scanner 1, laser scanner 2, video camera.

An extensive field measurement project is being performed in the Eems-Dollard estuary in the north of the Netherlands for a period of 12 years. The measurements started in 2018, measuring wind, water levels, waves and wave run-up and overtopping. The estuary consists of deep channels and shallow tidal flats and is part of the Wadden Sea, a shallow shelf sea, see Figure 1. A particular aspect for this area is that the dike design conditions are characterized by very obliquely incident waves, up to 80° relative to the dike normal. As the reliability of the models as used for the Dutch dike safety assessment has not been sufficiently validated for such conditions, the aim of the measurements is twofold. First, to better understand the processes yielding nearshore wave conditions, ultimately leading to improved numerical prediction models. Second, to better understand the processes related to oblique wave run-up and overtopping, leading to improved prediction methods. In the project, the wave overtopping is measured with four wave overtopping tanks built into dikes at two locations. The laser scanner system of Oosterlo et al. (2019) has since been upgraded and has now been placed next to two of the overtopping tanks on the dike in the Eems-Dollard estuary to measure during actual severe winter storms, see Figure 2.

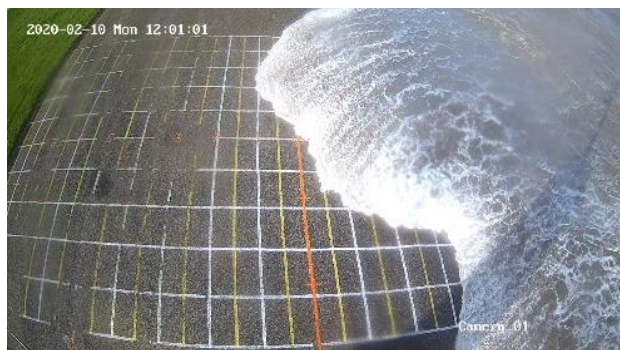
Figure 3 - Snapshot of a very oblique wave running up the slope during storm Ciara.

The focus of the paper will lie on the measurements performed during storm Ciara. Storm Ciara was an extratropical cyclone that hit large parts of northern Europe starting on 7 February 2020. Measurements were performed from 10 to 12 February 2020. Ciara was the first actual storm that was measured with the laser scanner system, and immediately tested the system to the extreme. Ciara was a highly unique storm, with offshore directed wind at the measurement location and waves that turned somewhat on the shallow flats in front of the dike to become almost alongshore directed waves at the dike. Hence, Ciara caused highly complex conditions at the measurement location with very oblique wave attack with angles of incidence up to 75°. This posed large challenges for measuring e.g. the 3D front velocities and the overtopping volumes and discharges, also see Figure 3.
