Experimental and Numerical Assessment of Historical Steel-Concrete Composite Bridge Decks Without Mechanical Connectors

Poliotti, Mauro; Yang, Yuguang; De Boer, Ane

Building for the Future: Durable, Sustainable, Resilient

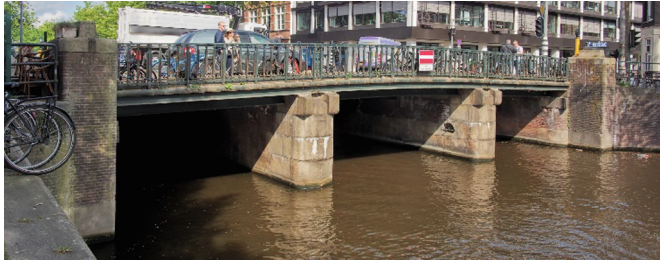
Fig. 1. Picture Bridge 70 Vijzelstraat, Amsterdam. Picture adapted from Google.

A particular type of bridges that has brought attention lately is the steel-concrete-composite slab deck. These bridges were designed and built between 1880 and 1960, and around 150 are still in operation in Amsterdam [1]. These bridges are multi-span bridges, and the cross-section of the deck is composed of partially encased steel beams, see Fig. 1 and Fig. 2.

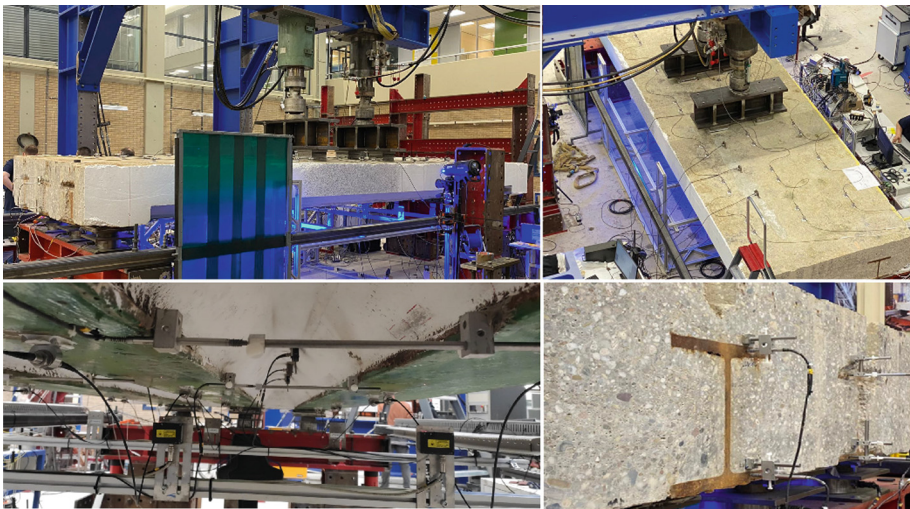
Fig. 5. Test and instrumentation. Top Left: side overview; Top Right: top view and optic fibers. Bottom Left: Bottom view transverse LVDTs; Bottom Right: Side view end LVDTs.

The sensor plan is designed to track several key parameters of the behaviour during testing. Reactions are monitored by 6 load cells placed under the steel beams. Vertical displacements are tracked by a grid of 12 laser sensors placed under the specimen. Strains on concrete deck and steel beams are measured by means of 42 discrete optical fiber sensors with a base length of 200 mm. Steel strains are measured on the bottom flange at the center line of each beam. Concrete strains are measured on the top layer aligned vertically with the steel measurements. The interface behaviour is monitored using 8 LVDTs at different locations. At the end of beams 4 LVDTs are placed to measure the total slip between concrete and steel. Moreover, relative longitudinal slip between the

bottom flange and the surrounding concrete are tracked at four different locations by means of 4 LVDTs. The relative transverse displacement between the central and outer beams is measured by 6 LVDTs attached to the bottom flanges of the steel beams. Finally, 2D and 3D DIC cameras are used to monitor cracking from the side and bottom of the specimen, respectively. See Fig. 5. Full details of the measurement plan can be found in [8].

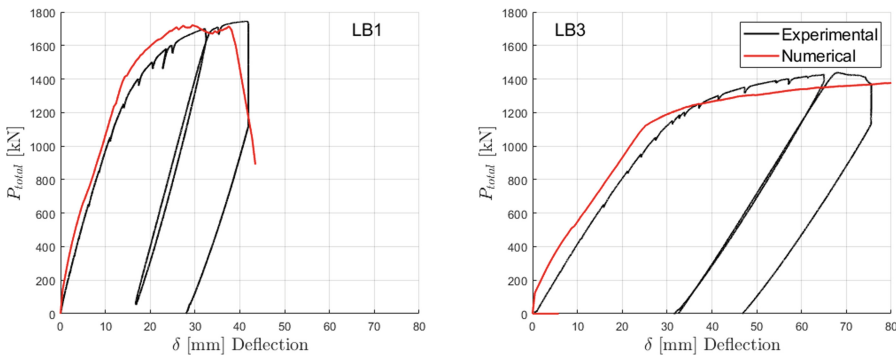
Fig. 8. Total applied load vs deflection curves obtained experimentally and numerically

The experimental load-deflection curves of both specimens are shown and compared with the simulation results from the numerical models in Fig. 8.

Comparing both experimental curves, it can be seen that LB3 has more ductile behavior, while LB1 shows a sudden drop of its bearing capacity with limited deformation. Further, it can be seen that good agreement is obtained between numerical and experimental results in terms of maximum load and stiffness. The ductility of LB1 is also well captured by the numerical simulation.
