Colour, Form and Space
Rietveld Schröder House Challenging the Future

RIETVELD
SCHRÖDER
HOUSE
CHALLENGING
THE FUTURE

Marie-Thérèse van Thoor [ed.]

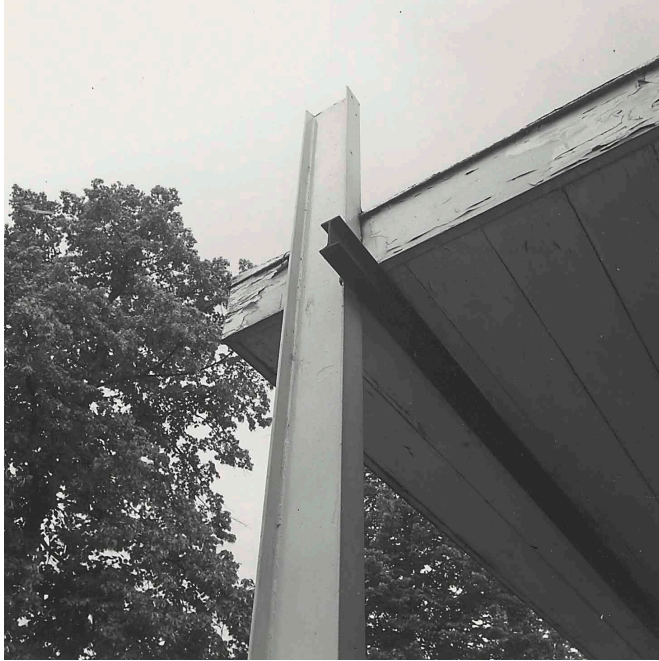
FIG. 1.4 Unconventional constructions made the house vulnerable

This was mainly because Rietveld considered the spatial effect and associated appearance, and the optical effect, more important than a stable and sound construction [FIG. 1.4]. This had resulted in unusual combinations of traditional and modern materials (and their properties) and techniques which, after the passage of so many years had started to exhibit all manner of defects. For example, the way the steel beams had been tailed into the (single-skin) brickwork had led, through the action of moisture, to rust and hence to cracks in both brickwork and plaster. At Rietveld's insistence, the concrete slabs used for the balconies had to be very thin so that here, too, moisture had been able to corrode the steel edges, which had started to rust, and the concrete had begun to display cracks [FIG. 1.5].

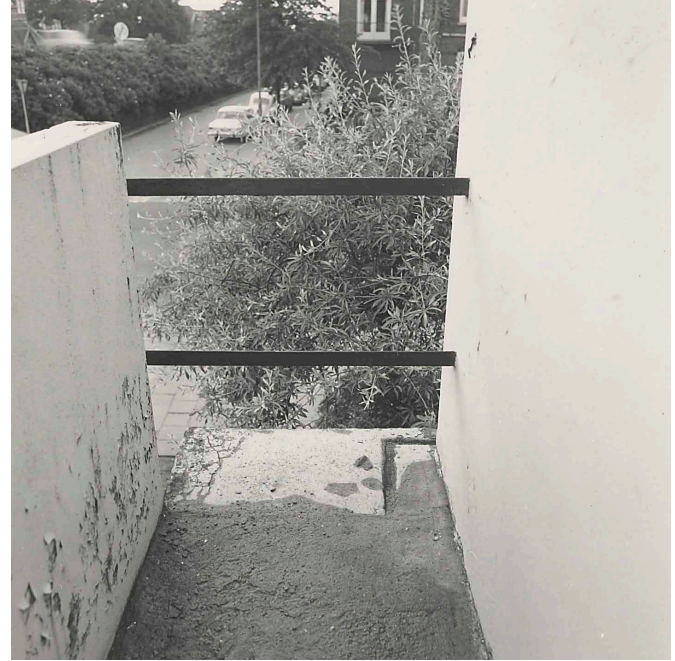
FIG. 1.5 After 50 years the concrete of the balconies also showed signs of cracks and damage

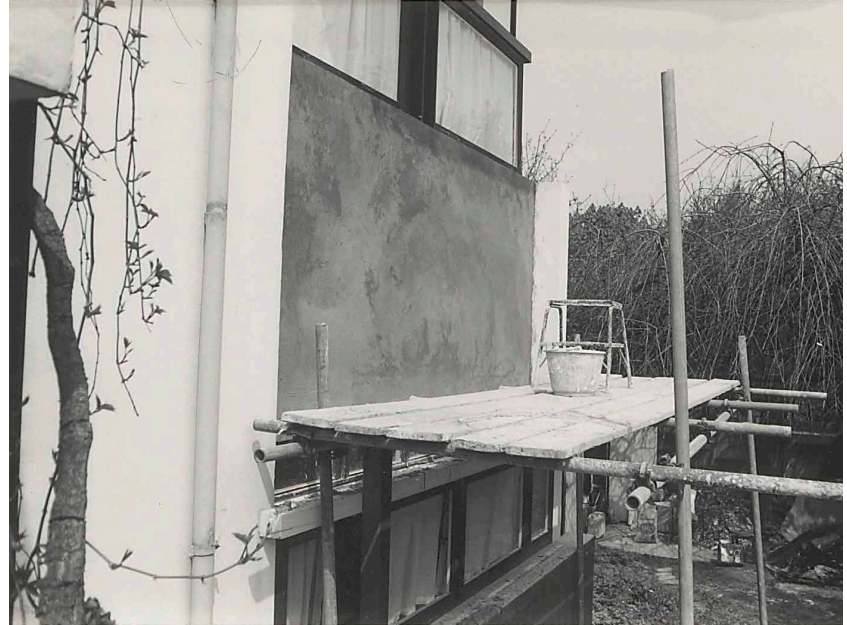
FIG. 1.11 After the plaster with hairline cracks was removed, the new render was applied in a single homogeneous coat

Work started at the end of April and after the removal of the layer of mortar it was discovered that the repairs to the brickwork using synthetic mortar had held up well. The substrate was homogeneous, and according to Geerken the brickwork was of reasonably good quality.³⁹ Thus the problems lay with the rendering. Even more radical decisions were then taken on site. 'The render that had remained in place during the restoration also had to be removed in order to achieve a single homogeneous plaster coat and to avoid problems with joins between old and new work [FIG. 1.10/1.11].'⁴⁰ Whether this literally meant that all the

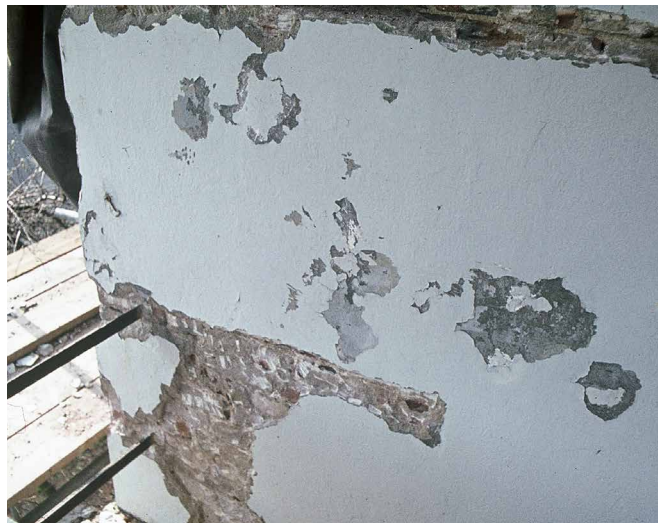
FIG. 2.7 In various places, such as the chimney, B. Mulder found still more finish coats and colours that he could include in his colour research

Upon inquiry Mulder turned out to have yet more information in the form of a series of slides and a set of colour samples.²⁰ Detail photos of the chimney show various finish coats and it appears possible to distinguish several colours. Even more interesting is a photo of the wall below the kitchen window in the east elevation [FIG. 2.9]. We can see various shades of grey, from light to dark, and between them the white of a base coat. Mulder's caption reads: 'I opted for a dark grey from top right corner.'²¹ This is one of the wall surfaces that were not repaired and on which the original plaster is still present, according to Mulder. Nevertheless, we are left guessing about the dates of these grey coats because there is simply no further documentation and also because references to other wall surfaces are lacking. The layers of paint on the walls, which were entirely stripped in 1979, were removed together with the old layers of render.

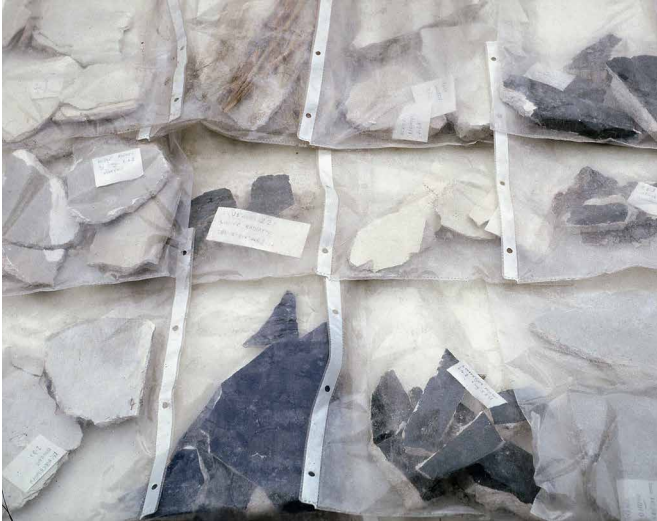
FIG. 2.8 Plaster and colour samples packed in plastic bags

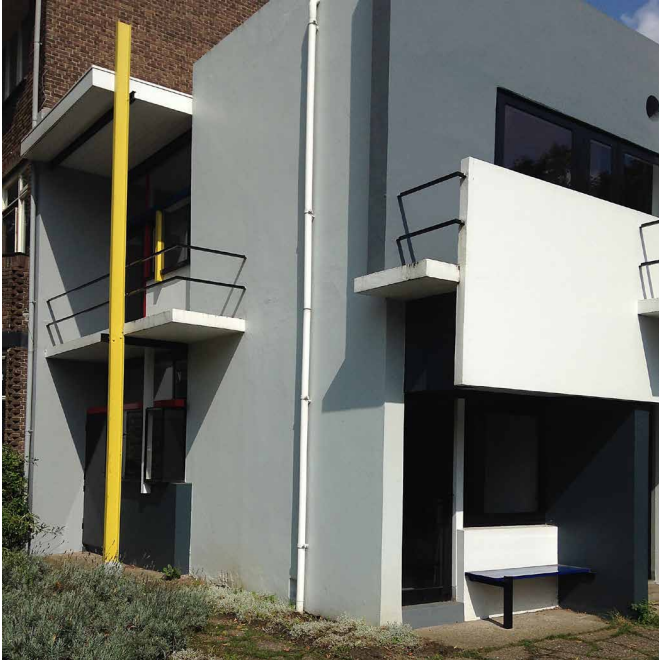
FIG. 2.11 Prins Hendriklaan wall, white rainwater pipe against pale grey background, 2017

The various rainwater pipes were eventually treated in different ways. We can see both white against a pale grey surface (large wall Prins Hendriklaan) [FIG. 2.11] and pale grey against a white surface (to the right of the front door) [FIG. 2.12]. The pipe on the rear elevation is white against a white wall, and that next to the neighbouring building at Prins Hendriklaan 48 is pale grey against an identical pale grey background. This does not appear to be in accordance with the earliest period of the house. In photographs, especially those taken straight after the construction, the rainwater pipes are a natural zinc-grey in colour. But Mulder did regard the drainpipes and their colours as important elements of the overall composition. In an interview with *Cobouw magazine* in November 1974, a few months after the letter from Han, he raised the question of the rainwater pipes himself, in particular the white-painted downpipe on the ‘side elevation’, against the grey background. This downpipe had been absent for a while, was then painted in a zinc colour, and thereafter ‘painted white as [was] intended against the grey background’.³⁰ Thus, even the colours of the rainwater pipes could completely alter the character of the walls.
