## In-plane response of slender walls made of calcium silicate brick and element masonry

Esposito, R.; Ravenshorst, G. J.P.; Rots, J. G.

Esposito, R., Ravenshorst, G. J. P., & Rots, J. G. (2021). In-plane response of slender walls made of calcium silicate brick and element masonry. *Heron*, 66(1), 37-60.

Faculty of Civil Engineering and Geosciences, Delft University of Technology, the Netherlands

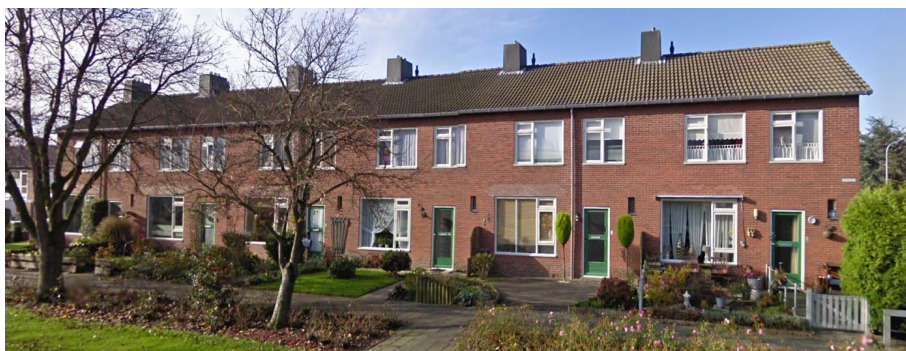
Figure 2. Typical Dutch terraced house (Esposito et al. 2019)

topic. Among others, terraced houses represented one of the most vulnerable building typology largely spread over the area (Figure 2). Terraced houses often present a load-bearing inner leaf structure made of CS masonry.

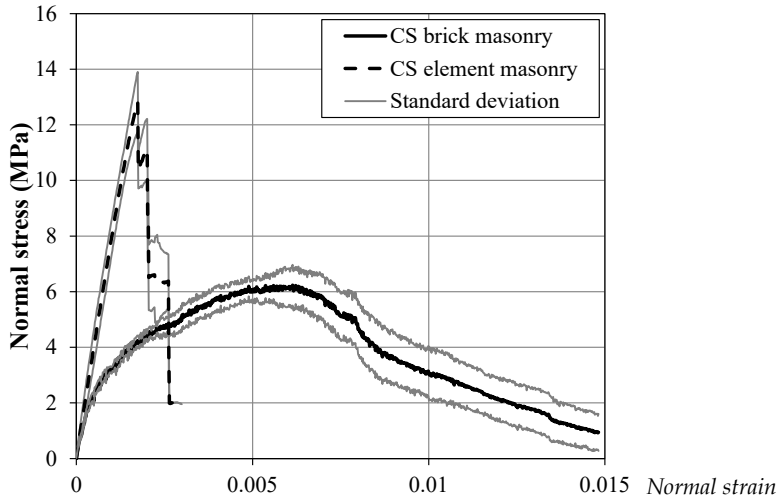
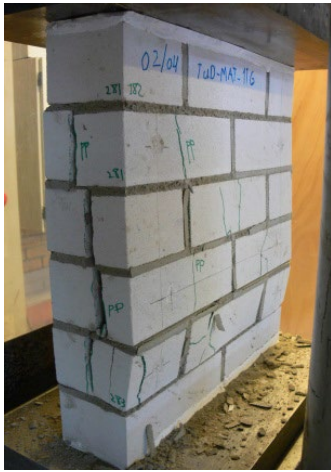
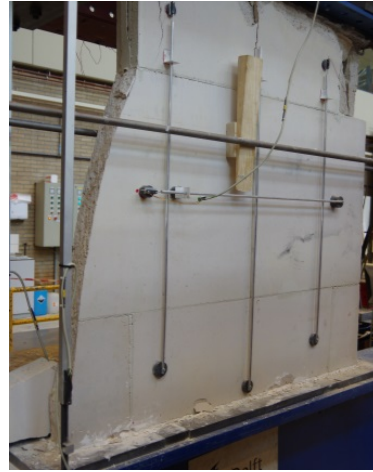
Figure 3. Compression tests perpendicular to bed joints (adapted from Jafari et al. (2018))

(a) Mean stress-strain curves and standard deviation

(b) CS brick masonry failure mode

(c) CS element masonry failure mode

The CS element masonry showed a higher compressive strength and elastic modulus with respect to the CS brick masonry. In the pre-peak phase, the CS brick masonry showed a linear-elastic phase followed by a slight decrease of stiffness prior to reaching the peak stress, while the CS element masonry showed a linear behaviour. After the maximum stress was reached, a softening behaviour was observed for the CS brick masonry, while a brittle failure was reported for the CS element masonry (Fig. 3).

The CS element masonry wall tested under double clamped configuration (TUD\_COMP-24) showed a pure rocking mechanism followed by a brittle failure with a sudden reduction of the force capacity. Upon cracking of the first and last bed joint (cycle C3), the wall deformed monolithically without showing any further damage. In the last cycle (cycle C13), brittle damage of the wall suddenly occurred in the following sequence: (i) sliding at the bottom two courses occurred leading to the head joint opening; (ii) formation of a vertical crack in the top two courses; (iii) splitting (over the thickness) of the bottom unit in the right-bottom corner. The sudden reduction in force capacity was determined by the formation of an unstable mechanism created by the cracking in the elements. This is in line with the brittle failure mechanism observed during the compressive tests (Fig. 3).

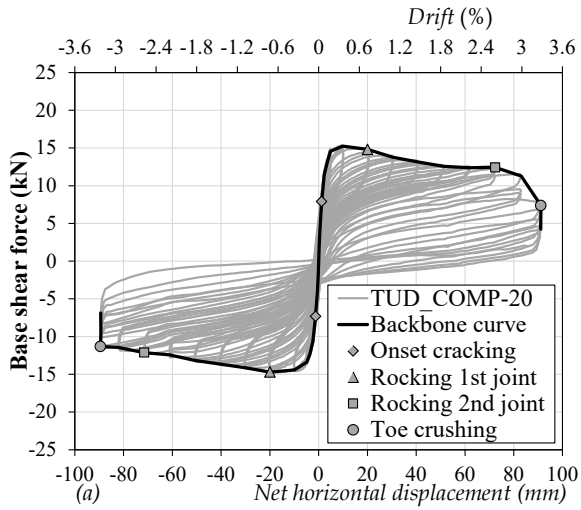
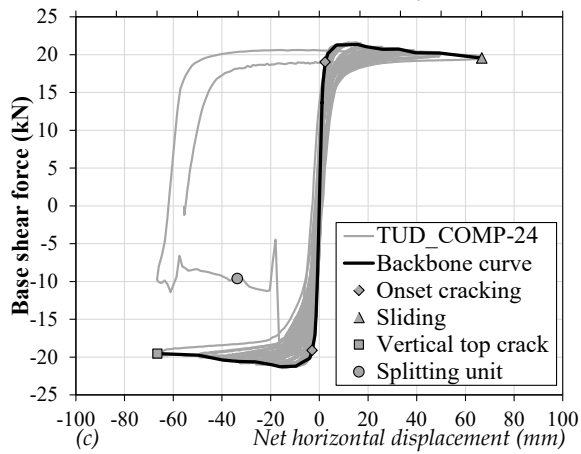
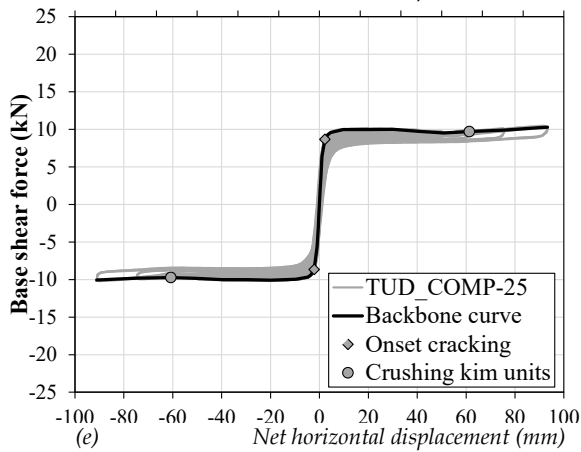
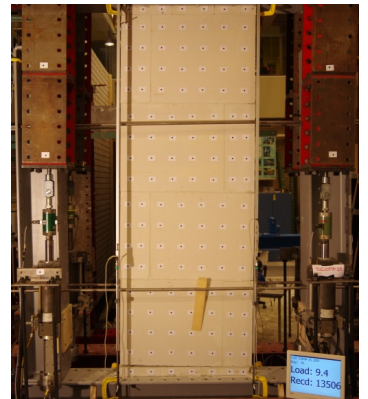
Figure 5. Hysteretic curve, envelope curve, equivalent bilinear curve and final crack pattern (corresponding approx. to circle marker): (a), (b) CS brick masonry wall TUD\_COMP-20; (c), (d) CS element masonry wall TUD\_COMP-24; (e), (f) CS element masonry wall TUD\_COMP-25

Figure 5 shows the global response of the walls in terms of base shear versus drift curve and crack pattern observed in the last cycle. The graphs show the hysteretic behaviour, the backbone curve and its bilinear approximation. The backbone curve was defined by considering the maximum displacement achieved in each cycle (usually occurring in the first run) and its corresponding force. The evaluation of the equivalent bilinear curve is discussed in next section. An overview of the main experimental results is given in Table 4. The CS brick masonry wall tested under cantilever configuration (TUD\_COMP-20) showed a rocking mechanism followed by toe crushing resulting in a gradual reduction of the force

capacity in the post-peak phase. During cycle C1, smaller horizontal cracks started to arise in the bottom three mortar layers and in cycle C6 the first mortar layer was completely damaged ensuring the full activation of the pure rocking mechanism. Due to the rocking deformation, the damage progressively involved the second bed joint at the bottom of the wall leading to the reduction of the effective height (cycle C11). During cycle C12, splitting cracks at the bottom-left and bottom-right corner of the wall occurred, leading to detachment of masonry portions on the left-hand side. In cycle C13 and C14, where the same jack's displacement was imposed, the phenomenon of toe crushing could be observed; the base shear force decreases substantially for the same imposed displacement. This phenomenon led to instability of the wall for large displacements and its complete collapse.

The CS element masonry wall tested under cantilever configuration (TUD\_COMP-25) showed a pure rocking mechanism without degradation in force capacity. The damage

started in cycle C2 with the formation of a horizontal crack at the first bed joint; the crack could reach a maximum crack opening of 25 mm leading to the monolithic deformation of the wall. Minor damage was also observed in the bottom kicker layer, where crushing was observed at the bottom-left and bottom-right corner starting from cycle C10. During the same cycle, out-of-plane deformation started and it reached a maximum value of 4 mm at the bottom of the wall. This resulted in a misalignment between the wall and the kicker layer. A similar phenomenon was also observed in the quasi-static cyclic test on full-scale two-storey building (Puente et al. 2018, Esposito et al. 2019). Despite the absence of relevant damage in the wall, the test was stopped due to the relative large drift value attained ( $d_r > 3\%$ ).

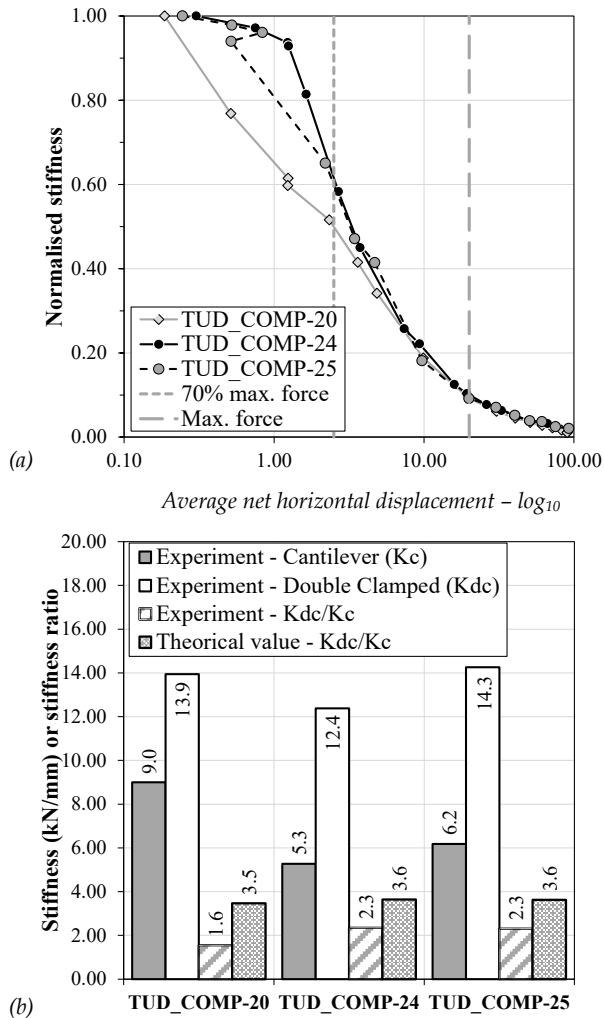
Figure 6. (a) Stiffness degradation; (b) Initial stiffness evaluated for cantilever and double clamped configuration (theoretical value calculated considering  $E_2$  and  $G = 0.4 E_2$ )

Figure 6 shows the normalised stiffness as a function of the normalised average net horizontal displacement. The stiffness was calculated considering a linear interpolation of the hysteretic curve for every cycle. The normalised value for the stiffness and the average net displacement were calculated by considering the initial stiffness in the first cycle (Table 4) and the ultimate displacement, respectively.

The CS brick masonry wall (TUD\_COMP-20) shows a rapid degradation of the stiffness, while the curves for the CS element masonry walls (TUD\_COMP-24 and TUD\_COMP-25) show an initial plateau for the first four cycles. This difference can be related to the fact that after the first mortar joint was cracked, the CS element masonry wall showed a monolithic deformation associated to pure rocking. On the contrary, the CS brick masonry wall showed progressive cracking of the first two bed joints, which lead to a progressive reduction of the effective height. For larger deformation, the walls show a similar behaviour.

To evaluate the stiffness of the walls both in cantilever and double clamped configuration, cycle CID was imposed prior to the cyclic test considering both boundary conditions (pre-test). Figure 6b shows the experimentally obtained value for the cantilever,  $K_c$ , and double clamped,  $K_{dc}$ , configuration and its ratio together with the theoretical value as per beam theory. The theoretical value has been calculated considering the elastic modulus evaluated at 1/10 of the compressive strength  $E_2$  (Table 1) and assuming that the shear modulus  $G$  of masonry is 40% of its elastic modulus. Considering these assumptions, it is

possible to notice that the theoretical stiffness ratio is approximately 2 times higher than the one obtained experimentally.

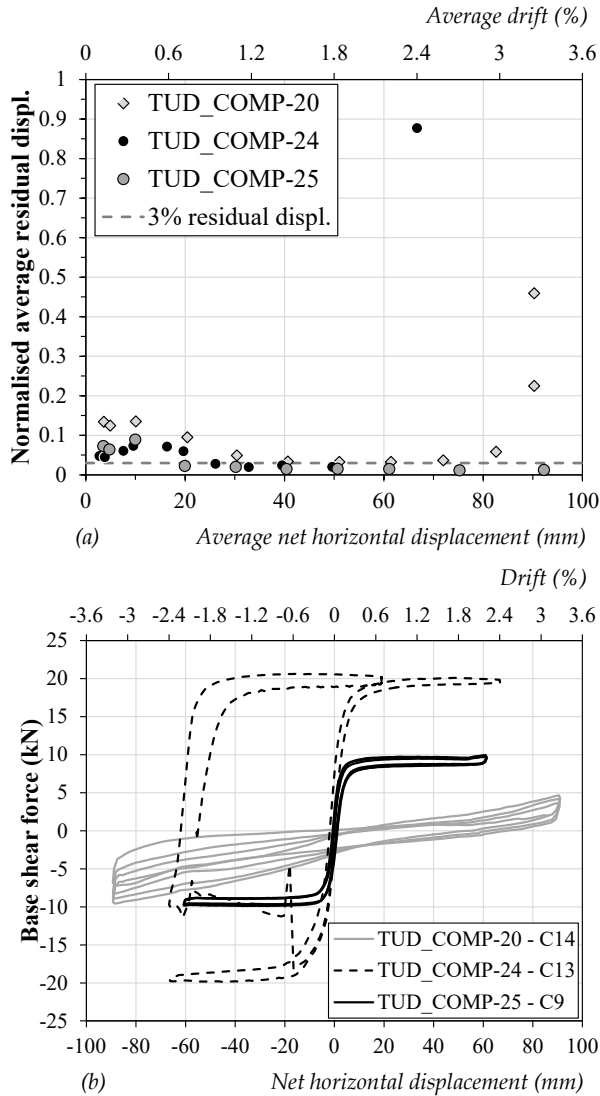
Figure 7. (a) Normalised average residual displacement in the last (complete) run of each cycle; (b) Cycle with the largest residual displacement

The walls showed large residual displacements. Figure 7 shows the normalised average residual displacement as a function of the average net horizontal displacement in the last (complete) run of each cycle, and the hysteretic curve for the cycle showing the largest residual displacement. The normalised residual displacement was calculated as the ratio between the displacement at zero force (residual displacement) and the peak displacement achieved in the corresponding half run. For sake of clarity, in Figure 7a the data is shown for drift value larger than 0.05% (cycle C3).

Prior to the formation of extensive crack pattern, for every wall the normalised residual displacement tends to a constant value of approximately 3%. The cantilever walls (TUD\_COMP-20 and TUD\_COMP-25) show a similar trend, while the double clamped wall (TUD\_COMP-24) initially shows a normalised residual displacement 2 times lower than the cantilever walls.

For larger average net displacement, every wall shows an increase of residual displacements that can be associated to the damage evolution. For the CS brick masonry wall (TUD\_COMP-20), a sudden increase in residual displacement is observed in the last two cycles (C13 and C14) where damage due to toe crushing was observed. Considering that in those cycles the wall shows similar net horizontal displacement, it is possible to notice that the toe crushing mechanism lead to an increase from approximately 22 to 46% in normalised residual displacement due to the repetition of similar runs. This phenomenon is also confirmed by the evolution in hysteretic behaviour shown in Figure 7b. For the CS element walls different behaviour is observed due to the substantial difference in crack pattern. For the double clamped wall TUD\_COMP-24, which showed extensive damage, a sudden increase in normalised residual displacement is observed in the cycle with a residual displacement of approximately 90% of the imposed one. Due to the absence of extensive damage in the masonry units for the cantilever wall TUD\_COMP-25, the normalised residual displacement is nearly constant and an increase is observed only at drift value of 1.7% (Cycle C9) that is caused by sliding of the wall on the first bed joint, as can also be observed in the hysteretic curve in Figure 7b.

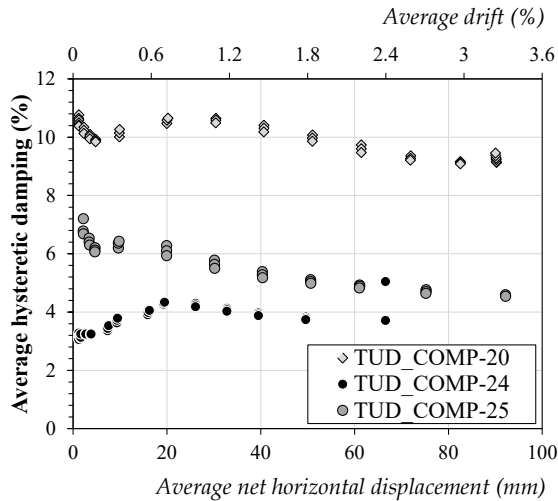
Figure 8. Hysteretic damping

been calculated considering the area within one complete run of stabilized force-displacement response. Figure 8 shows the average hysteretic damping as a function of the average net displacement. To exclude the influence of possible friction in the actuators for low displacement, the value of hysteretic damping is given only for net horizontal displacements larger than 1 mm.

The walls show a nearly constant trend for the average hysteretic damping as a function of the average net horizontal displacement. The CS brick masonry wall (TUD\_COMP-20) shows the highest hysteretic damping being approximately 10%, while the CS element masonry walls show lower values, ranging between 4 and 5%. This difference can be related to the different damage mechanisms occurring for the two types of masonry. Thanks to the smaller unit size and the presence of thicker joints, the CS brick masonry can be considered more flexible with respect to the CS element masonry and it can dissipate more energy thanks to the activation of different local mechanisms such as splitting of brick, crushing of mortar, and sliding at mortar-brick interface. Additionally, the CS element masonry wall tested under cantilever configuration (TUD\_COMP-25) shows a more pronounced initial degradation of the hysteretic damping with respect to the other two walls. For the double clamped CS element masonry wall (TUD\_COMP-24), a sudden increase in hysteretic damping is observed in the last cycle as a consequence of the brittle damage.

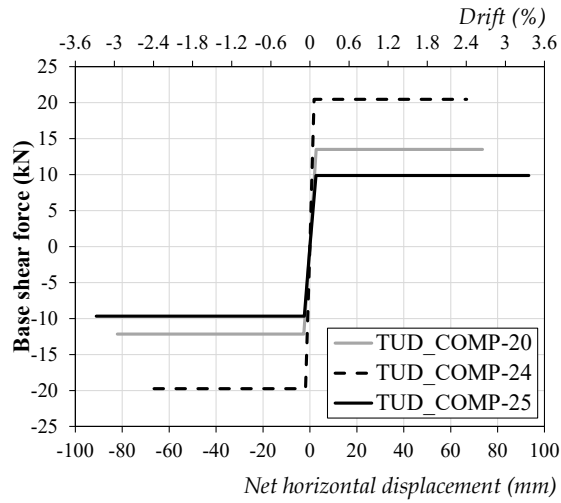
Figure 9. Equivalent bilinear curves

To compare the performances of the walls in terms of force and displacement capacity, the equivalent bilinear approximation is adopted. The effective stiffness  $K_{eff}$  of the equivalent bilinear curve was evaluated at 70% of the maximum base shear force. The ultimate displacement  $d_u$  and its corresponding drift value  $d_{r,b}$  were determined from the backbone curve at a residual force capacity equal to 80% of the maximum base shear force. The ultimate base shear force  $V_u$  of the equivalent bilinear curve was determined by imposing that the energy dissipated up to the ultimate displacement  $d_u$  is the same for the backbone and the equivalent bilinear curve. The elastic displacement  $d_{el}$  was calculated as the ratio between the ultimate base shear force and the effective stiffness ( $V_u/K_{eff}$ ), while the ductility  $\mu$  factor is calculated as the ratio between the ultimate and the elastic displacement ( $d_u/d_{el}$ ). The main parameters of the bilinear approximation, obtained as average of the ones calculated for the negative and positive loading direction, are given in Table 5, while the equivalent bilinear curves for the two loading directions are shown in Figure 9.

The difference in crack pattern and energy dissipation of the two materials results relevant for the definition of the bilinear approximation. Due to the absence of progressive damage accumulation for the CS element masonry walls, the equivalent bilinear curve nearly resembles the backbone curve. On the contrary, the equivalent bilinear curve for the CS brick wall deviates approximately 10% from the backbone curve, both in terms of force and displacement capacity. In every case, the ductility factor is high confirming that the walls can withstand large deformation after the elastic phase. As already observed in Figure 6, the effective stiffness (Table 5) is approximately 50 and 85% of the initial stiffness (Table 4) for cantilever and double clamped configuration, respectively. However, the initial stiffness is evaluated for very small displacement thus it can be less representative of the structural response of the wall.
