Comparing overflow and wave-overtopping induced breach initiation mechanisms in an embankment breach experiment

Myron van Damme^{1,a}, Luc Ponsioen¹, Monica Herrero² and Patrik Peeters³

¹Delft University of Technology, Department of Hydraulic Engineering, 2628CN, Delft, The Netherlands

Abstract. As part of the SAFElevee project Delft University of Technology collaborated with Flanders Hydraulics Research, and Infram B.V. in the preparation and execution of a full scale embankment breach experiment in November 2015. This breach experiment was performed on an 3.5m high embankment with a sand core and clay outer layer situated along the tidal river Scheldt in Belgium near Schellebelle. During the experiment a wave overtopping simulator and overflow simulator were used to initiate a breach. Both simulators were placed near the top of the waterside slope. The use of the simulators facilitated comparison between the effects of continuous overflow and the effects of intermittent wave overtopping. This paper presents the data collected during the experiment, describe the development of hypotheses on the failure processes using the latest insights, and comment on the failure initiation p

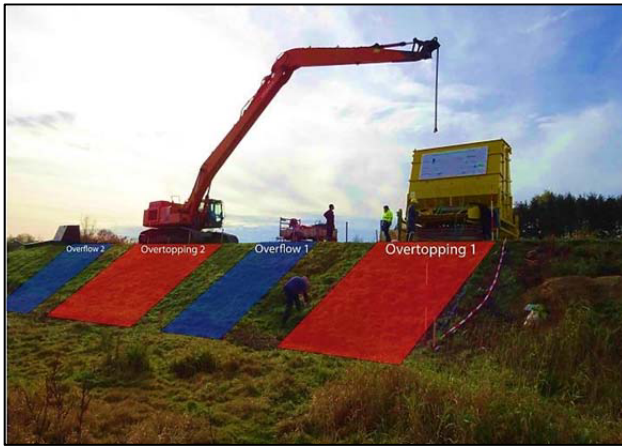
Over an approximate 50m long stretch of embankment, two tests were performed on breach initiation due to wave overtopping using the 4m wide wave overtopping simulator developed by Van der Meer [5], [6][7]. Also two breach initiation experiments had been performed using a 2m wide overflow simulator developed specifically for this experiment by Delft University of Technology. An overview of the test sections has been depicted in Figure 1.

Figure 1. Overview test locations on embankment.

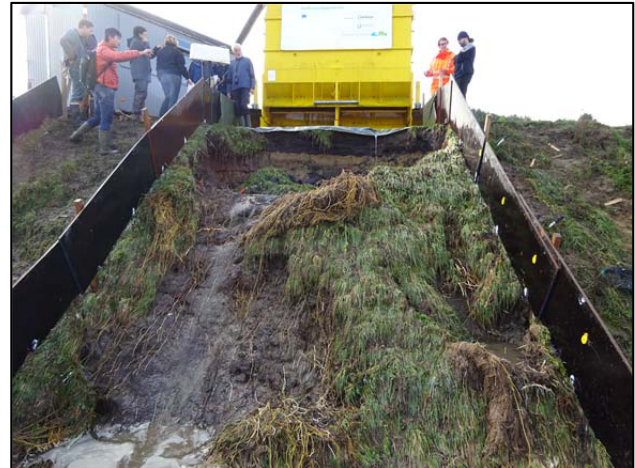
During the 10 l/m/s it was noted a hole had formed with a diameter of approximately 0.2m, 1m below the top of the landside slope in Section 4A. Further analysis showed that this was a rabbit hole. Water infiltrating the rabbit hole caused for erosion and the formation of a hole near the outflow, which was located 5m west of the test

site. At the end of the 10 l/m/s test, the hole had grown to approximately 0.5m deep. During the 25 l/m/s the hole in on the slope increased in size. After 3 minutes, part of the grass cover came loose near the hole. After 12 min the sand layer was reached in the hole. Once the sand layer was reached a trench developed due to erosion downstream of the hole (see Figure 4)

Figure 4. Overview picture taken at the end of the 25 l/m/s tests at the first test section

Simultaneously headcut erosion caused for the upstream progression of the hole. The sand under the clay layer acted reasonably cohesive maintaining near vertical slopes. The processes observed during the retreat of the landside slope were similar to the underwater breaching process as observed during dredging at sand pits. Here the dilation of sandy soil due to water infiltration in combination with the reduction of negative pore pressures determine the rate of erosion and prevent large scale slope failures from occurring.

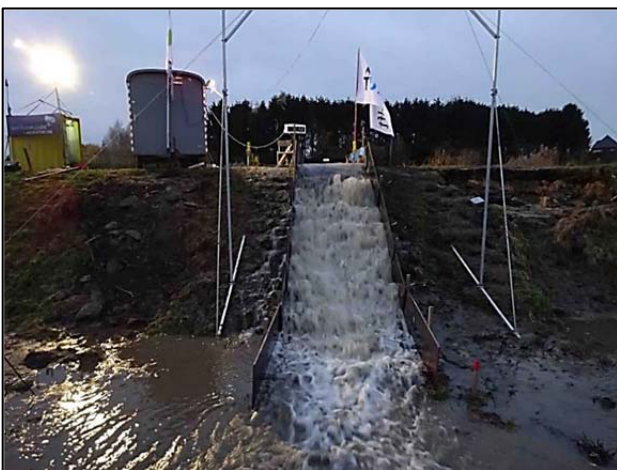
Due to limitations in the minimum allowable frequency at which the pump could be operated, tests with the overflow simulator started at 10 l/m/s, followed up by 25, 50 l/m/s and 85 l/m/s. Contrary to expectations, the damage that occurred to the grass cover at overflow discharges of 50 l/m/s and 85 l/m/s was negligible. Instead of the theoretical nice smooth flow of constant density, during all overflow tests the flow became highly aerated down the landside slope (see Figure 6). This could be of influence to the spatial velocity distribution down the slope. Between changes in the discharge the flow was stopped during which became apparent that contrary to the behaviour of grass during wave overtopping the grass cover remained in a flattened position and did not bounce back upwards. Another noticeable, and potentially important observable difference with the wave overtopping tests, was that during overflow the reattachment point of the flow was closer to the crest than during wave overtopping. The normal impact at the reattachment point is therefore also expected to be smaller during overflow than during wave overtopping. These differences with wave overtopping could potentially help in better explaining the difference in timing in failure initiation of the grass cover.

Figure 6. Observed aerated flow during the overflow experiment
