# Push-out tests on demountable shear connectors of steel-concrete composite structures

## Abstract

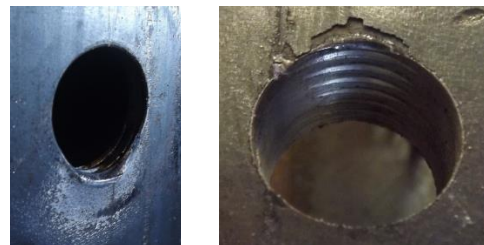
As shown in Fig. 11, minor damages were observed on the elements of the specimens: bearing failure of the L-profiles, and the thread shapes were visible on the bearing surface of the holes of the steel beam.

Fig. 11. Observed damages (P3.1-1)

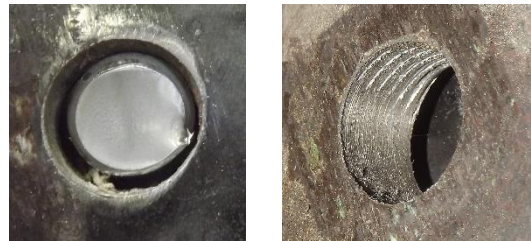
As shown in Fig. 16, no bearing failure occurred in the L-profile. However, the shape of the threads could be observed in the bearing surface of the holes of the steel beam.

Fig. 16. Observed damages (P15.1-1)
