**Laser Scanning of Damaged Historical Icons  
Surveying Technology is Heading for Maturity**

GIM International: the worldwide magazine for geomatics

# Laser Scanning of Damaged Historical Icons

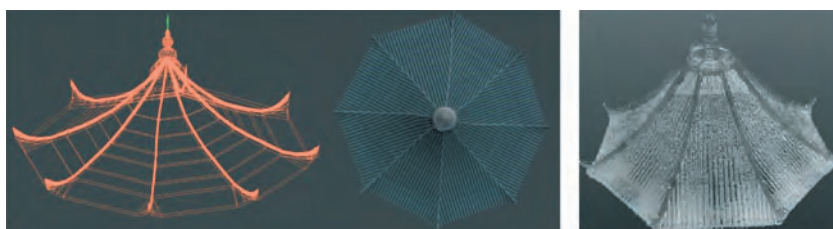
▲ Figure 2: Two views of the 3D models of the roof of the Liuhe Pagoda (left) derived from a laser scanning point cloud.

The Liuhe Pagoda (Six Harmonies Pagoda), located at the mouth of the Qiantang river in Hangzhou, Zhejiang province, China, has been demolished and rebuilt several times since originally being constructed in AD 970. Today it is a major tourist attraction (Figure 1). In addition to suffering human devastation, forces of nature have caused the monument to decay. Combined with the size of the pagoda, which is 13 storeys tall, this makes it a challenging restoration project. In 2013, its fourth major repair and renovation project began. The interior and exterior were scanned over a period of six months to support restoration. After scanning, which took three minutes per scan position, the building was modelled to find the missing parts, which required two to three hours per scan (Figure 2). Next the missing parts were designed, crafted by hand and assembled. For quality assurance and control inspections and detailed 3D documentation, the building was scanned using a compact 3D laser scanner resulting in 23 billion 3D points.

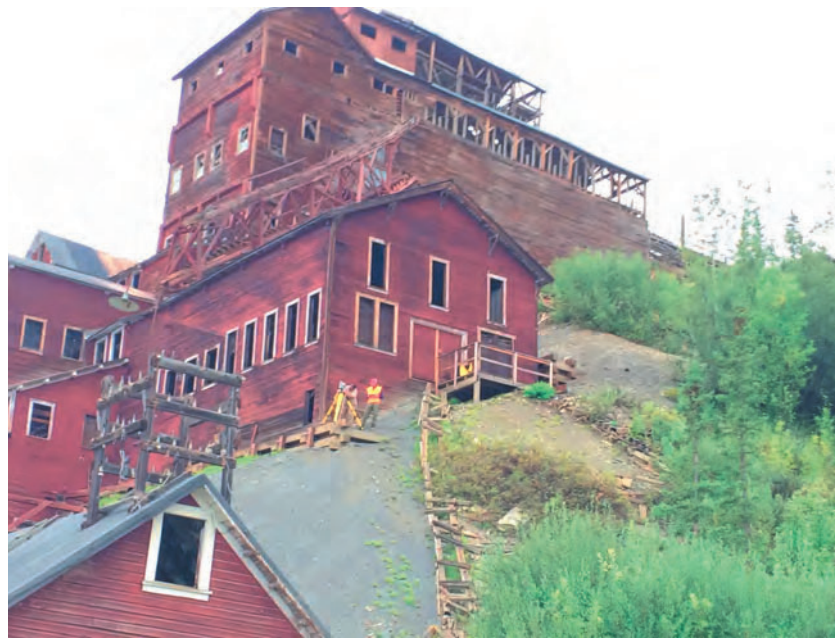
▲ Figure 3: Copper ore was milled and melted in furnaces in this building at Kennecott Mines, Alaska.

site's iconic 14-storey building received raw ore delivered by aerial trams and delivered processed copper to railcars (Figure 3). To preserve the site after nearly 80 years of neglect, the site was placed under protection and mapped. In 2018, to improve detail and accuracy, the site was scanned during a three-day period using a Trimble SX10 scanning total station. The same instrument also measured individual points of key features of the building, such as roof and wall-corner points. The blue lines visible in Figure 4 show the traverses of the SX10 and the individual points. Ground control points were measured using Trimble R8 and R10 GNSS receivers; the base lines are shown in green. The traverse and GNSS measurements were combined with Trimble Business Center (TBC) software and registration and georeferencing was done with Trimble RealWorks.

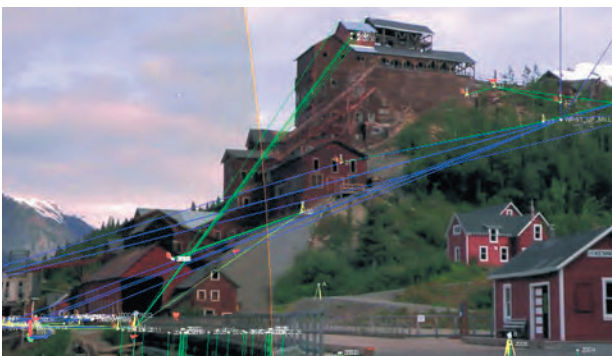
▲ Figure 4: A georeferenced photo mosaic of the Kennecott mill viewed from the valley floor, created using Trimble VISION.

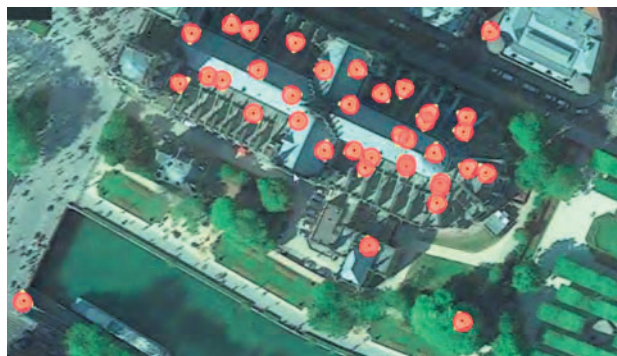
▲ Figure 5: In this aerial view of Notre-Dame Cathedral in Paris, orange circles represent the scan positions during the 2010 TLS survey.

about the cathedral's pre-fire stage. Fortunately, however, Prof Andrew Tallon – an architectural historian from Vassar College in the USA – had captured the entire cathedral using a Leica Geosystems TLS in 2010 (Figure 5). That accurate and detailed point cloud will be of tremendous help in obtaining a faithful reconstruction of Notre-Dame in its original state.

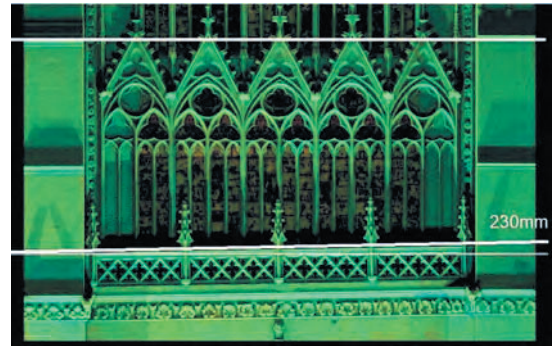
▲ Figure 6: Misalignment of the balcony of the south facade of Notre-Dame Cathedral in Amiens.

This illustrates the urgent need for accurate and detailed 3D models of cultural heritage sites, before disaster strikes or the natural elements erode their splendour. Detailed 3D reconstruction from dense TLS point clouds may also uncover construction details. For example, TLS revealed that the apparent skewness of the balcony of the south facade of Notre-Dame Cathedral in Amiens is not an optical illusion but is actually due to a 23cm height difference between the left and right sides which was caused by them being constructed independently (Figure 6).
