TIMBER AS BRIDGE BETWEEN PAST AND FUTURE: STRUCTURAL UPGRADING AND CONSERVATION OF THE ANCIENT TIMBER AND MASONRY VENETIAN SAWMILL OF VALLARO (BRESCIA, ITALY)

Michele Mirra[1], Andrea Gerardini[2]

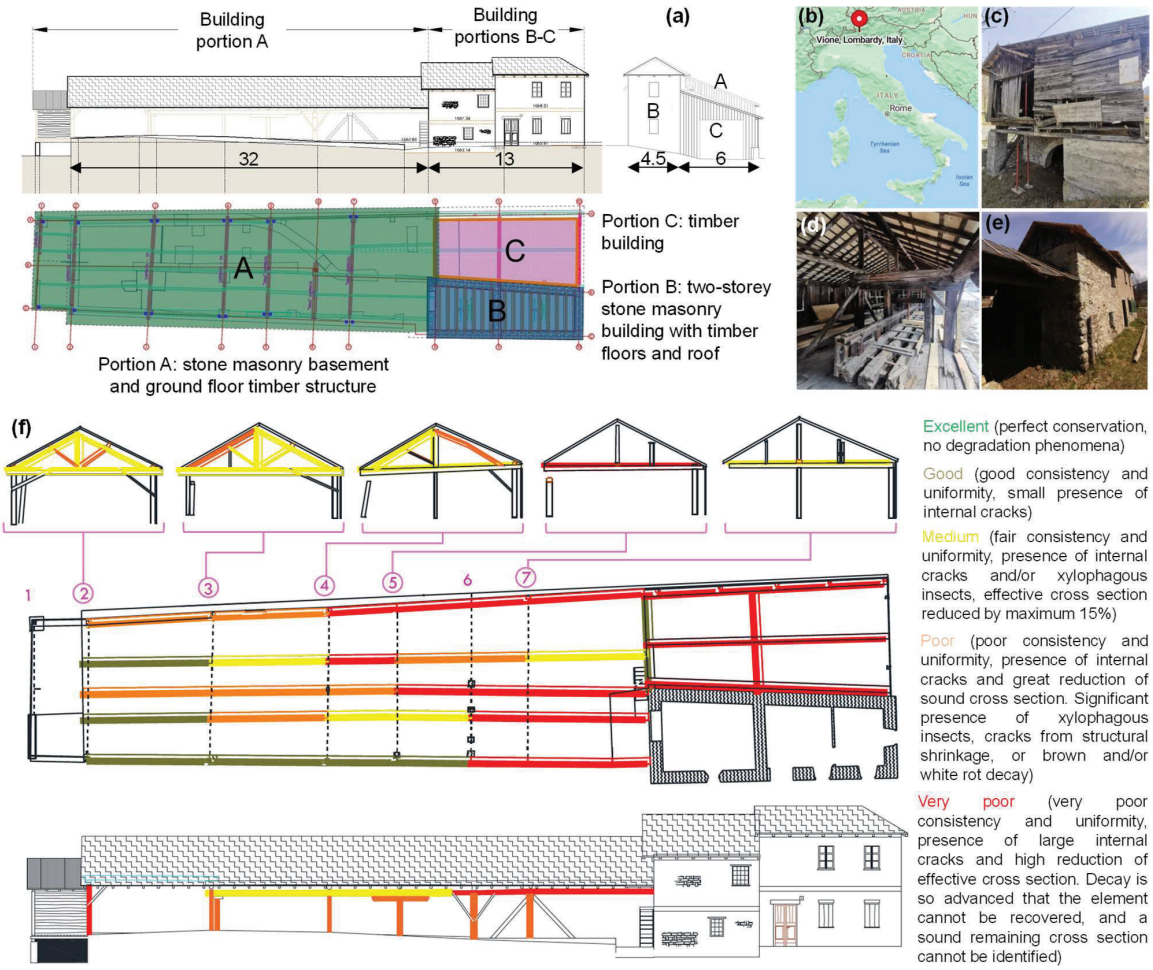
Figure 1. Plan and prospects of the case-study sawmill (a) and its location in Northern Italy (b); external (c) and internal (d) views of portion A of the sawmill before retrofitting; view of portion B (e); results of the assessment of the conservation of timber structural elements based on micro-drilling measurements (f), with classification of the conservation state following Italian standard UNI 11119:2004 [27], kindly provided by Ph.D. Eng. Dario P. Benedetti [28].

The existing structure was the result of a series of interventions carried out over time, causing overlapping between original members and later included elements, often poorly implemented with incompatible or low-quality materials. These factors, along with the past neglect of the building in the last decades, have contributed to the apparent poor conditions of the sawmill from the conservation point of view (Fig. 1), with extended degradation phenomena caused by water infiltrations from the roof. In light of the visually observed poor state of the sawmill, several investigations were conducted to assess the conditions of the existing structural elements. In particular, detailed on-site inspections on the stone masonry in 10 different locations were undertaken, and micro-drilling measurements were carried out on the timber members in 41 locations to assess their state, by means of an IML-RESI Power Drill 400 having a 3-mm needle. This comprehensive on-site assessment allowed to reconstruct the conservation state of the main timber structural elements (Fig. 1f), following the classification of Italian standard UNI

11119:2004 [27]. The wooden roof structure of portion A, including the trusses and timber columns, was found in an overall poor state of conservation after the past neglect of the building; the ground timber floor featured some sounder elements, but part of it was strengthened in the past with an incompatible 20-mm-thick concrete slab. In portion B and C, the evident signs of decay in the timber elements were confirmed by the outcomes of the micro-drilling measurements, based on which a very poor state of conservation was assigned to these structural members.

Based on the on-site performed investigations, several main vulnerabilities were found in relation to the future use of the building as a museum. Portion A presented insufficient load-carrying capacity of the wooden columns, with the existing structures able to sustain static actions only because of provisional works. The wooden members in the floors and the roof were decayed and very undersized for the future increased design loads. Furthermore, the past interventions consisted of incompatible reinforced concrete structural elements that were also found in poor state of conservation. Local cracks were detected in masonry walls of building portions A and B as well. Finally, all horizontal structural elements were not able to create an effective diaphragmatic and dissipative action against seismic loads, and adequate joints between floors and walls were absent.

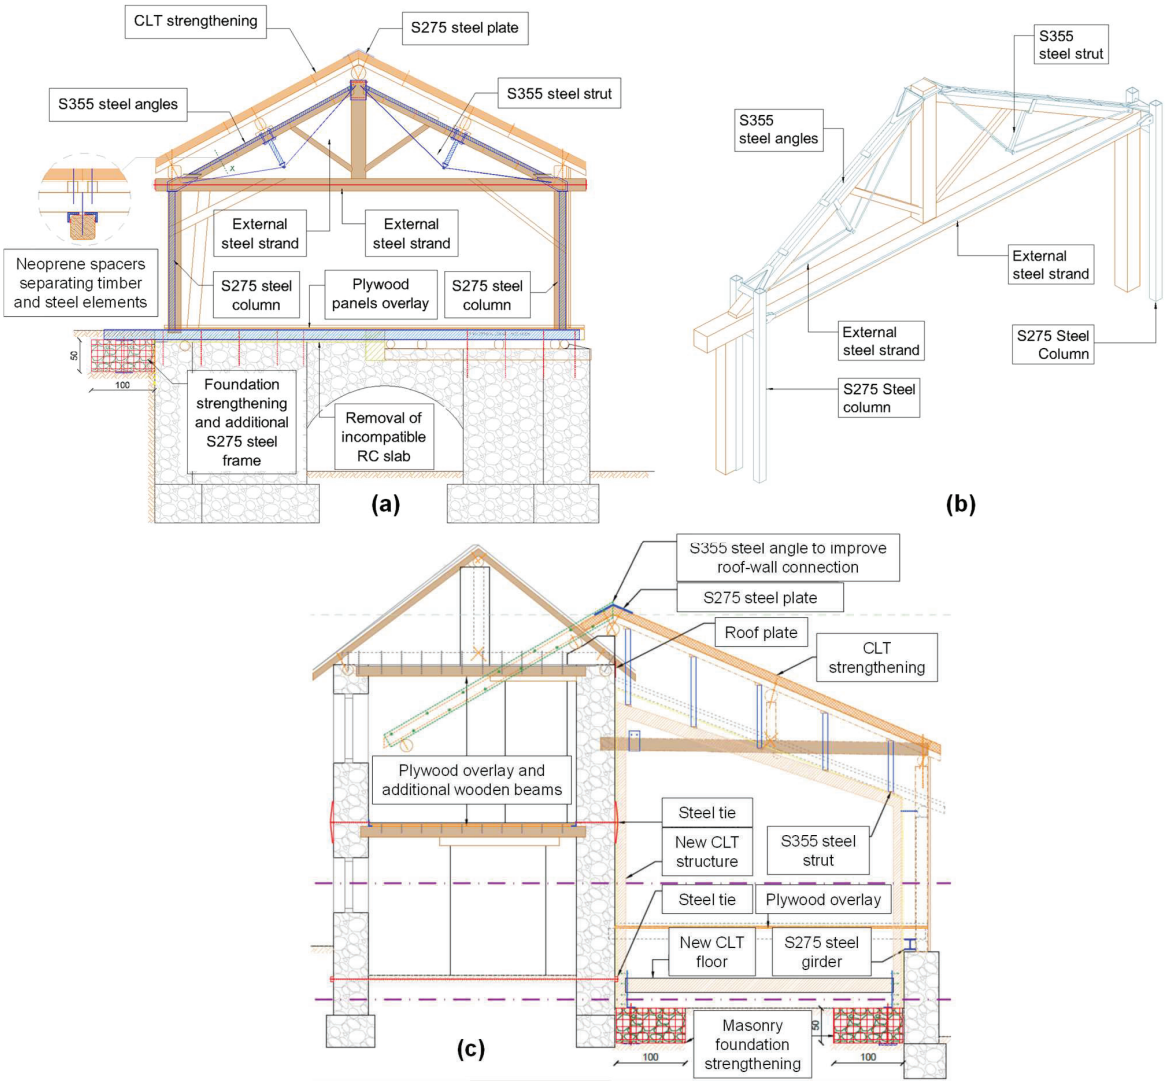
Figure 2. Representative overview of the designed integrated timber- and steel-based retrofits for the structural upgrading of the sawmill: interventions applied to portion A (a), including the principles adopted for strengthening the existing timber trusses (b), and to portion B (c) of the building.

For portion A (Fig. 2a), given the low residual load-carrying capacity of the decayed timber columns, newly integrated slender steel elements were designed, along with a new steel frame connected to the strengthened masonry foundations. In this way, both the static and seismic response of the structure could be improved. In consultation with the local Superintendence for Architectural Heritage, a wood-based solution was not adopted for this case, because it would have required very massive structural elements, which could have partly hidden the original appearance of the existing building. Instead, a timber-based strengthening was designed to preserve the wooden roof and enhance its structural response: 12-cm-thick C24 cross-laminated timber (CLT) slabs, along with additional steel strands, were adopted to improve the static behaviour of the roof, and enable its diaphragmatic action against lateral loads, while contemporarily preserving the existing wooden trusses. These were strengthened with particular care in minimizing the impact of newly added elements, and following the principles of similar successful past conservation interventions [5, 30]. Thus, through a combination of timber chocks, and steel ties, struts, and strands, the structural response of wooden trusses could be enhanced without the need for invasive interventions (Fig. 2b). Additionally, to guarantee sufficient ventilation around these existing ancient timber members, the steel angles around them were not in direct contact with the trusses, but slightly separated by means of neoprene spacers (Fig. 2a). Besides, also the ground timber floor was strengthened with 30-mm-thick plywood panels and additional wooden beams placed alongside the existing ones to improve the flexural and seismic response. All diaphragms were effectively connected to the masonry walls, by means of S275 or S355 steel angles and M14 or M20 threaded bars. All incompatible past interventions involving reinforced concrete elements, were demolished and integrated with new wooden or steel members, while the interior was restored and set up for the future museum activities (Section 4).

For portion B (Fig. 2c), flexural strengthening of the timber floors and roofs was necessary. This was realized by means of new timber beams of the same wood species, placed alongside the existing ones, and a 20-mm-thick plywood panels overlay fastened on them with 6×120 mm screws at 300 mm spacing. Besides, effective connections between horizontal and vertical structural elements were designed, including also new steel ties for an improved confinement of the stone masonry. In portion C, these measures were integrated with an entirely new prefabricated CLT structure, hosting the prospective location of the shop and café of the museum (Fig. 2c). The CLT module enables to support the existing wooden elements, which showed severe decay and excessive lack of load-carrying capacity. The designed solutions allowed to preserve as much as possible the original appearance and features of the sawmill, in spite of its poor conditions, while ensuring a safer, renovated environment for hosting a museum in this relevant, historic location.
