## Collapse of the Grimburgwal, a historic quay in Amsterdam, the Netherlands

## Research Article

# Collapse of the Grimburgwal, a historic quay in Amsterdam, the Netherlands

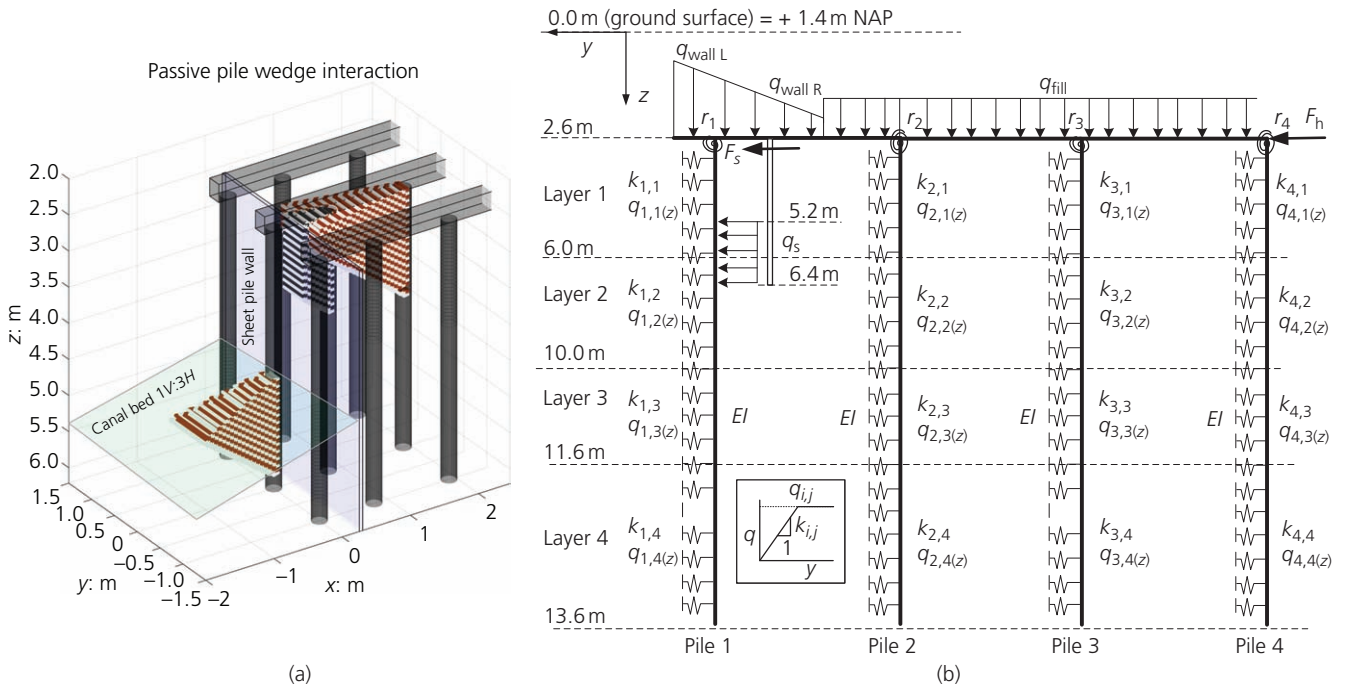
Some of the most important mechanisms are shown in Figure 9 and can be found in general sense in, for example, the handbook *Quay Walls* (De Gijt and Broeken, 2013) or the Dutch handbook of inner-city quay walls (Roubos and Grotegoed, 2014). From left to right, Figure 9 shows the horizontal bending of the piles and local geotechnical failure of soil around the piles, the overturning

The main failure mechanism was the horizontal bending of the piles as a result of a local deepening of the canal followed by breaking of the quay piles. This explanation assumes that only two rows of piles were present or functioned effectively over at least part of the quay. This is in accordance with the historic evidence and the underwater inspection and is also the most likely given the very short distance from the quay to the building behind it, where there is not enough space for a system with three piles. The long-existing cracks in the masonry wall reduced the possibility of redistribution of forces in the quay in the longitudinal direction, so that the loads could no longer be transferred to the stronger parts (with three rows of piles). The analyses were carried out with the assumption that the timber was not degraded, which to date needs to be confirmed. The presence

Figure 9. Most relevant failure mechanisms for the quay wall from left to right: horizontal bending of the piles and local geotechnical failure of soil around the piles, overturning of the masonry wall, cross-beam failure and horizontal sliding of the masonry from the deck
