**Calcium silicate against clay brick masonry
an experimental comparison of the in-plane behaviour during light damage**

Korswagen, Paul A.; Longo, Michele; Rots, Jan G.

Bulletin of Earthquake Engineering

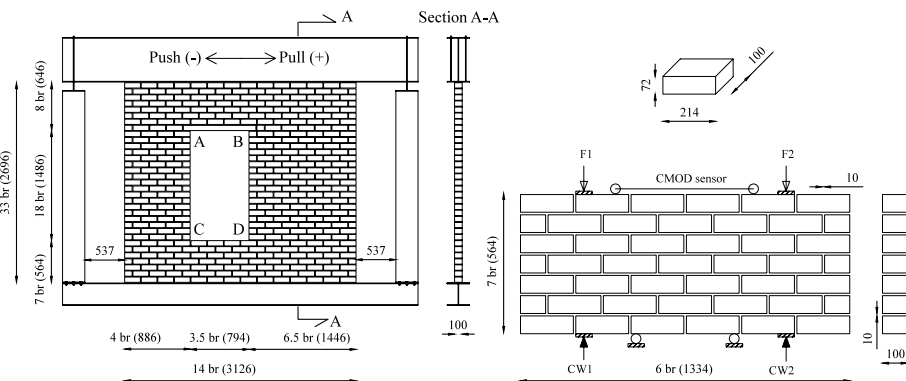
Fig. 1 Left (a), dimensions of the full-scale wall; and right (b), dimensions and loading scheme of the spandrel specimens. Values in millimetres

Two nominally identical full-scale walls (see Fig. 1.a) were identically tested in their plane under a small, constant pre-compression stress of 0.12 MPa and a displacement-controlled, cyclically-increasing lateral drift. The walls were single-Wythe and approximately 3.1 m in width and 2.7 m in height. A window opening, positioned asymmetrically in the wall, was included to better mimic field cases where cracks are usually seen around windows (corners), see for instance Grünthal et al. (1998). The wall was fixed to a bottom steel beam and to a top steel beam, the latter of which was allowed to displace and rotate in the plane of the wall thus simulating a cantilever boundary condition. The lateral edges of the walls were free to minimise the complexity of the tests while simulating typical structural cases where structural or infill walls are only tied to neighbouring (transversal) walls without interlocking of bricks.

Additionally, five spandrel samples (Fig. 1b) were tested in a modified four-point bending setup under a crack mouth opening displacement (CMOD) controlled scheme. This setup allows for the possibility of applying one-way cyclic loading by employing counterweights (CW) aligned on the underside of the sample opposing the location of two hydraulic jacks (F). Additional details about the experimental setup of the walls can be found in Messali and Rots (2018), and about the setup of the spandrels in Korswagen et al. (2019). The specimens were built to replicate calcium-silicate brick masonry as found in the Groningen area. A characterisation campaign was conducted to establish the material properties of the existing masonry and build laboratory equivalents of these, see Jafari et al. (2017). The wall also included a reinforced concrete lintel which did not participate in the development of damage.

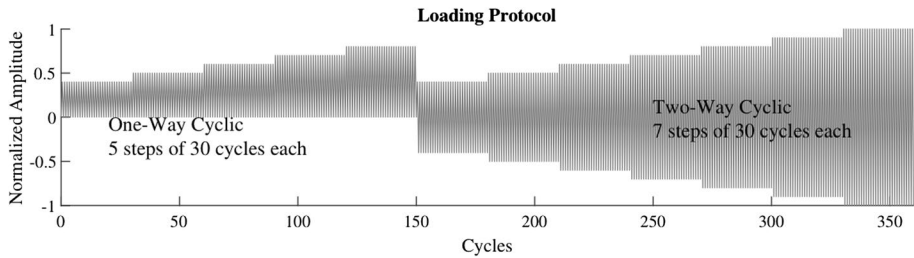
Fig. 2 Loading protocol of the full-scale walls

The loading protocol for the walls consisted of five incremental steps of one-way cyclic loading in the positive (or pull) direction, followed by another seven incremental steps two-way cyclic. Each step consisted of 30 cycles. The amplitude of the first step was 0.26‰ (lateral drift) and was increased 0.07‰ in every subsequent one-way cyclic step (until 0.55‰), and restarted at 0.26‰ at the beginning of the two-way cyclic portion of the protocol until finally reaching 0.70‰. A representation of the loading protocol, which was identical to the one used to test the clay-brick walls, is drawn in Fig. 2. The high number of small cycles included in the protocol are to mimic the effect of numerous light seismic or

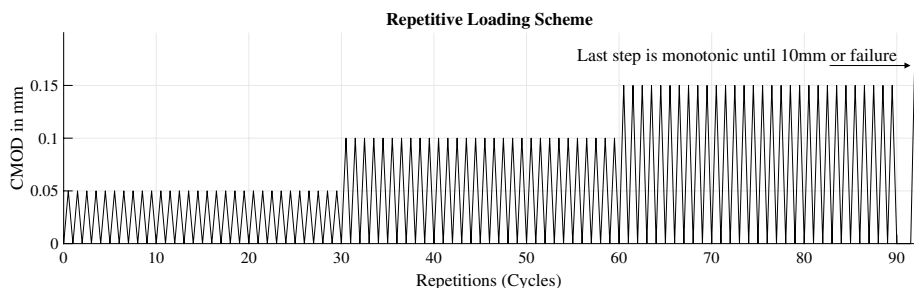
Fig. 3 Loading protocol of the spandrels

The spandrels were tested under a one-way cyclic scheme where the CMOD was first repeated 30 times at values of 50 μm , 100 μm , and 150 μm (for a total of 90 cycles) before being driven monotonically to 10 mm (though failure occurred before reaching this value). The repetitions had a lower boundary of a force of 1 kN to maintain stability in the system. Note also that the CMOD sensor was placed spanning the three top head joints to account for the possibility of a crack opening in any of these joints (Fig. 1b). See Fig. 3 for a representation of the loading protocol of the spandrels. A summary of the tested specimens and their protocols is given in Table 1.

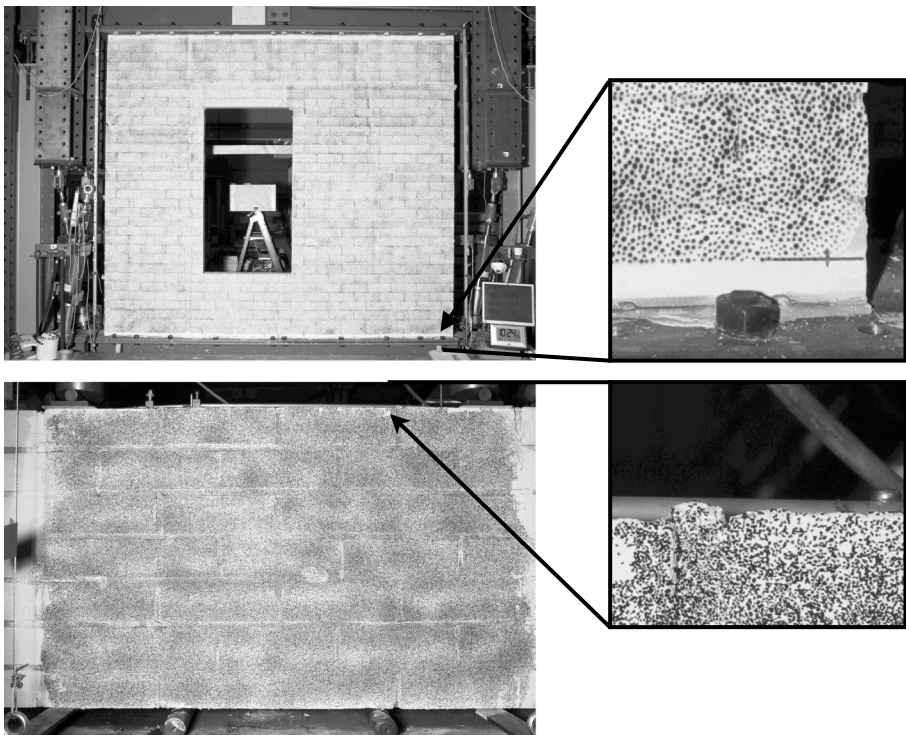
Fig. 4 Specimens of wall (top) and spandrel (bottom) with DIC pattern zoomed in

Both types of tests were monitored using the photogrammetry technique of Digital Image Correlation (DIC). The surface of the specimens was covered with a purposely-optimised random speckle pattern and photographed at specific time points throughout the tests (see Fig. 4). This allowed high-resolution measurement of the entire 2D, in-plane displacement field of the samples; in the case of the walls, approximately one million points were monitored at a distance of 2.8 mm between the points, and for the spandrels, 75,000 points at 2.4 mm distance were observed. The precision of the walls' measurement was 20 μm while for the spandrels, 5 μm . Additionally, traditional sensors and LVDTs were placed at the back of the wall and spandrels, and between the walls and the steel frames. Moreover,

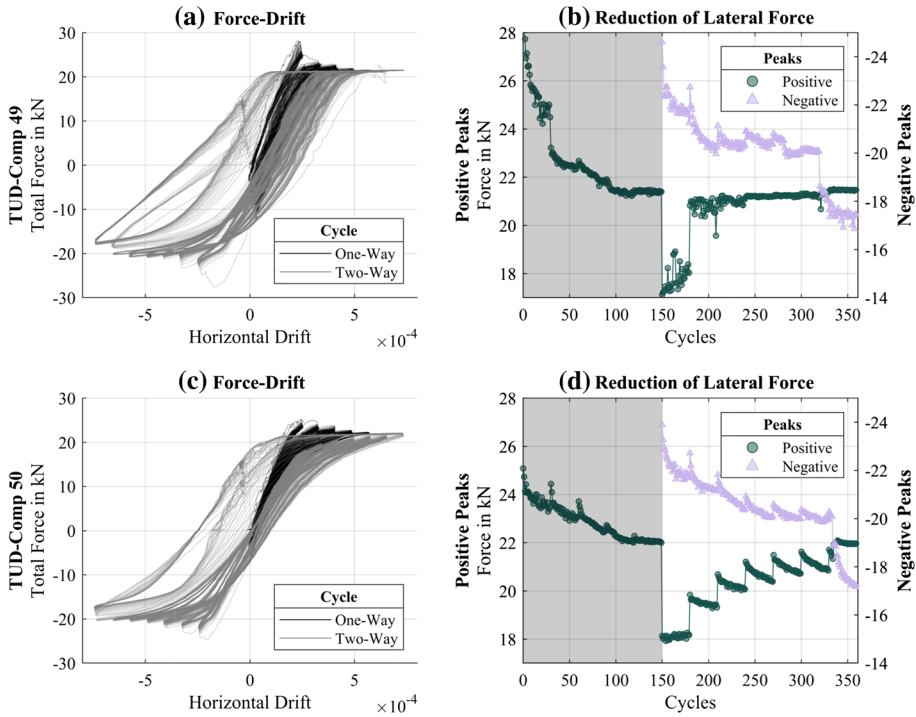
Fig. 5 Force-drift curves and cyclic degradation graph for the full-scale walls: TUD-Comp49 in **a, b**, and TUD-Comp50 in **c, d**

Both full-scale walls were incrementally displaced in-plane up to a drift of 0.7‰, which is low compared to drift associated with near-collapse in the order of 1–3%. Nevertheless, the walls exhibited considerable degradation in their cyclic force–displacement behaviour, see Fig. 5, left. Already after five one-way cyclic repetitions of the first imposed drift (0.26‰), the first wall had lost 2 kN of its peak lateral capacity (see Fig. 5b), which corresponds to about 7% of its strength. The right side of Fig. 5 shows thus the decline in peak force capacity (the absolute maximum attained in the positive and negative directions) for each consecutive cycle. Throughout the tests, a consistent decrease in peak force capacity can be observed for both walls of about 5% per step. Moreover, after the one-way test (initial 150 cycles with drift only in the positive direction and shaded in Fig. 5, right) had been finished and the initial positive drift was repeated, the walls showed a considerable reduction in strength of up to 30%: from approximately 25 to 17 kN, and from 24 to 18 kN for each wall respectively. Conversely, the capacity in the negative drift direction at the beginning of the two-way test was unaffected and began to degrade in a manner similar to that of the positive direction during the one-way test. Accordingly, for the first wall, the positive capacity showed almost no degradation during the two-way test, presumably because the one-way test had already damaged this direction; however, the second wall did show degradation but its capacity never exceeded what had been achieved during the one-way part of the test. Furthermore, both walls seemed to develop what would later have become the ultimate failure mechanism during the last step of the test; this is visible in all four graphs of Fig. 5. Both walls seem to accumulate significant lateral deformation leading to an increase in the hysteresis of Fig. 5a, c.

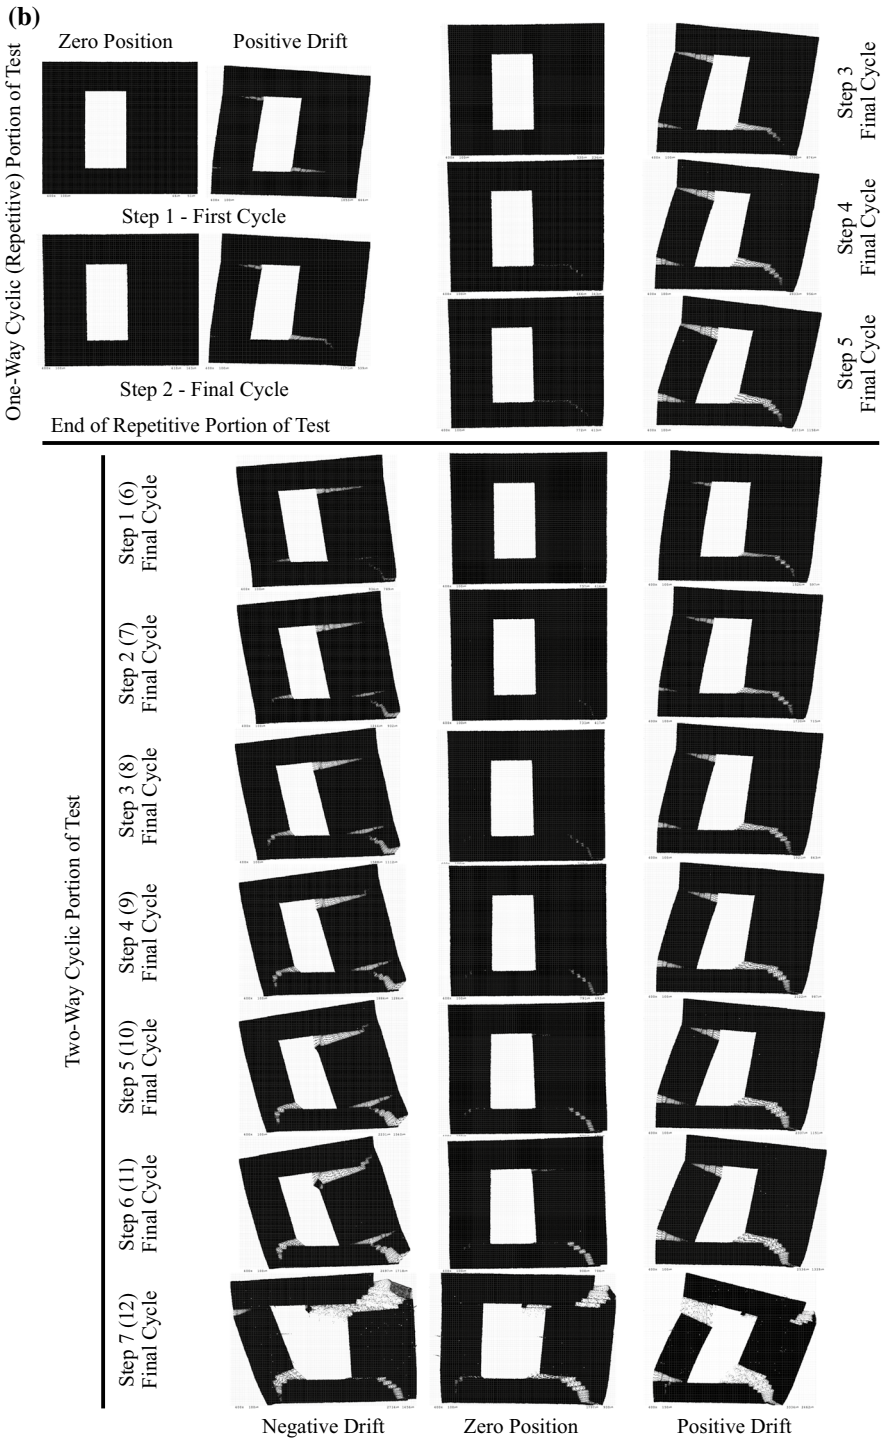
Fig. 6 400x magnified displacement field (deformed shape) for the **a** first wall, TUD-Comp49, **b** second wall, TUD-Comp50. Steps refer to the protocol of Fig. 2: 5 steps one-way cyclic (repetitive) followed by 7 steps two-way cyclic, (12) total steps

Fig. 6 (continued)

The force-drift and strength degradation of the wall throughout the test can be well traced to their behaviour and progressing damage which was accurately captured with DIC. Figure 6 shows the displacement field composed by tracking one million individual points; note that here the displacements have been magnified by 400 times and in reality no crack exceeded a width of 2.5 mm. During these observations, no lifting or rocking was detected in the walls and the out-of-plane deformations were negligible.

In Fig. 6a-1 (referring to step 1 in Fig. 6a, this notation continues) and Fig. 6b-1, the initiation of visible cracks can be appreciated. The protocol was designed such that the first

step corresponded to the start of DS1. Yet, for the first wall, Comp49, Fig. 6a-2 shows that the top crack (A, see Fig. 1) has propagated fully through the pier in a diagonal manner. This is not the case for Comp50, where crack A runs horizontally to the edge of the wall in step 3, and while open, remains horizontally connected to the top spandrel throughout the entire test (no crack sliding displacement). Conversely, crack A leads to accumulated sliding for Comp49 and the pier becomes fully detached from step 11 onwards (Fig. 6a-11). This residual damage is then also clearly visible at the zero positions of Fig. 6a and hints at a mixed mode (mode I and mode II) behaviour for this crack. For Comp50, it is crack D the one to accumulate the most sliding as begins to show in Fig. 6b-9. The ultimate failure mechanism develops fully in Fig. 6a-10 for Comp49 comprising cracks A and B, and in Fig. 6b-11, the last step for Comp50, with crack B. It is remarkable that the walls, after this repeating damage, ultimately decompose in four rigid bodies which slide and rotate against each other, with little elastic deformation remaining.

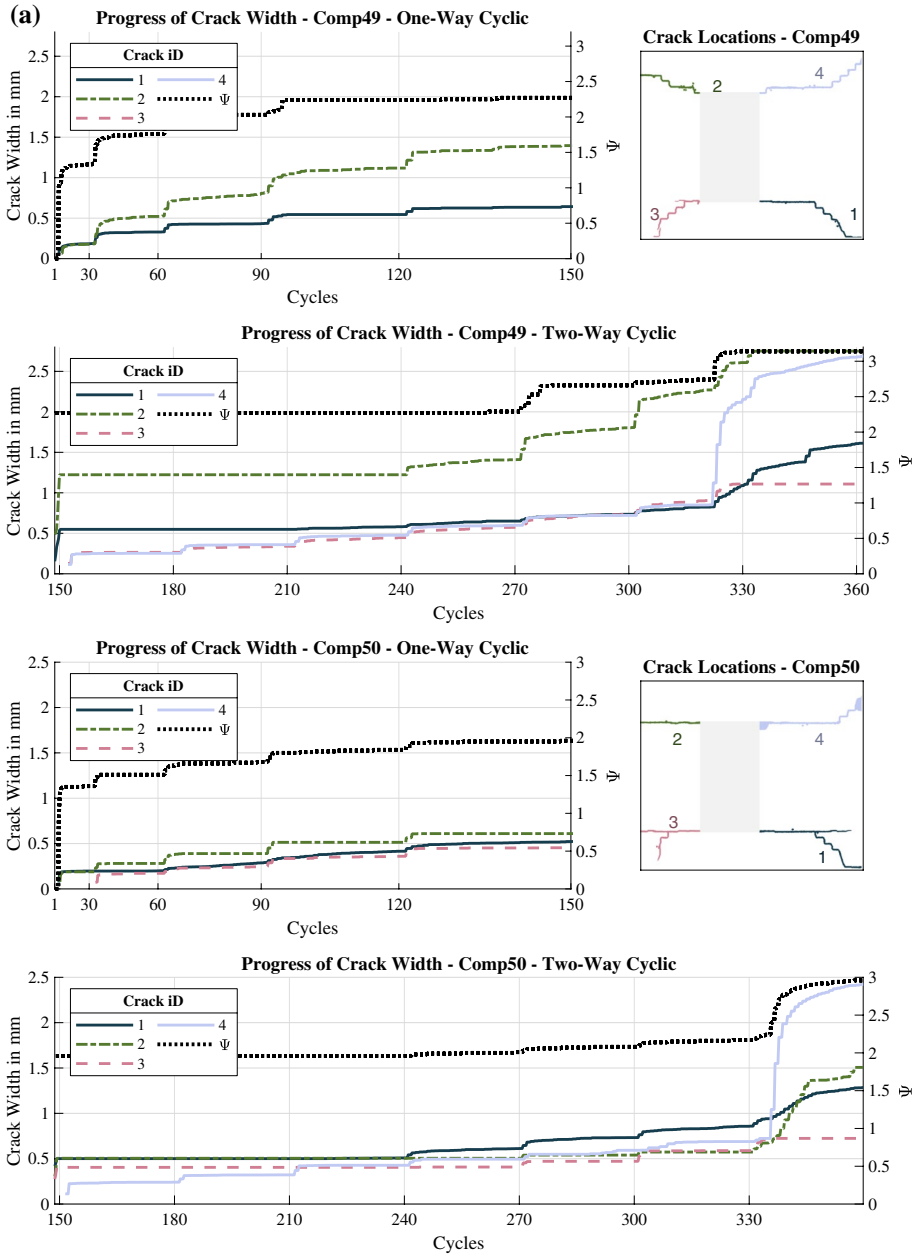
Fig. 7 a Progression of crack width for the full-scale walls. Maximum crack width of each crack for the entire cycle. Note that Psi (Ψ) is drawn on the right axis and corresponds to the damage intensity of the entire specimen. Top: Comp49; bottom: Comp50. b Progression of crack length for the full-scale walls. Top: Comp49; bottom: Comp50. Note that Psi (Ψ) is drawn on the right axis and corresponds to the damage intensity of the entire specimen

Fig.7 (continued)

The individual progression of the cracks and their representation of damage can also be extracted from the DIC data. This is shown in Fig. 7a where the crack width is plotted on the left axes and the damage parameter Ψ is measured on the right, the parameter is computed using the maximum crack width of each crack during each cycle. These graphs evidence the propagation of the cracks in every step, but also during certain steps, especially towards the end of the test. It can be observed that the behaviour of the cracks is linked as multiple cracks grow at the same time. During DS1 ($\Psi < 3$), cracks grow from 0.1 mm up to 2 mm and most have similar widths at any given time. For Comp50, crack 3

(C) propagated from both the outer edge of the wall during the one-way cyclic portion of the test as from the corner of the window later on. The propagation of the cracks is clearer in Fig. 7b where the length of the cracks (to a cut-off minimum crack width of 80 μm) is drawn. Here, the substantial increase in length within steps demonstrates that crack propagation must be (partly) responsible for the strength degradation observed in Fig. 5. Figure 7b also shows that crack 2 (A) is the first to propagate fully, revealing no growth in length already after the second step for both walls; then, crack 1 (D) reaches its full length at the beginning of the two-way portion of the test. This is presumably because both cracks are triggered by the one-way part of the test and hence experience a greater number of cycles.

It is also worth noting that cracks C and D, and also B for Comp50, run through bricks. This can be seen in the overview of Fig. 7 (and later Fig. 8), where, as cracks approach the edge of the wall, their paths become fully vertical instead of stair-case diagonal. Before these points, cracks follow the path of the mortar joints, and apparently, as the vertical weight of the wall rests on a few bricks when the wall is pushed laterally (see Fig. 6a-6 and -8 or Fig. 6b-9), the brick positioned in front of the vertical mortar joint at the edge of the crack is forced to split. For crack C, the split is fully vertical, while for crack D, the split is slightly inclined following the apparent path of the resultant force vector, suggesting that failure of the bricks is a mixture of bending and compression-induced tension-splitting (or compression-shear at the bed joint level). The path of the cracks is summed up in Fig. 8 overlaid on photographs of the wall.

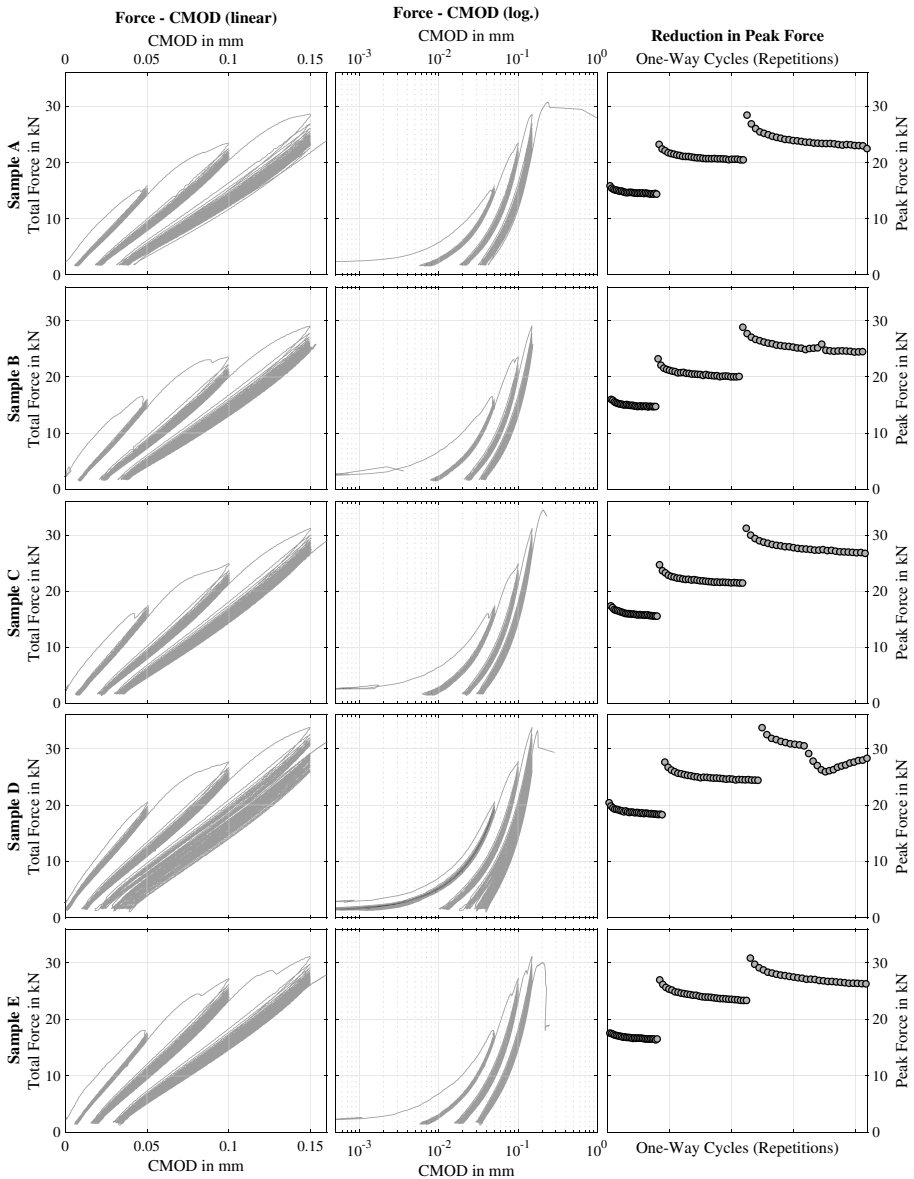
Fig. 10 Force against CMOD for spandrels tests, plotted linearly showing the cyclic steps (left), and logarithmically showing the entire test (middle). The force reduction identified via the peak of each cycle is also shown (right)

The sudden failure of specimen D, for example, can also be seen in Fig. 10, where the force-CMOD of the spandrels is shown. Figure 10 also evidences how the strength degradation that occurs during the cyclic steps is due to an accumulation of plastic, irreversible CMOD deformation at the lower force limit value of 2 kN, possibly due to sliding at the crack interfaces. The slope (stiffness) of each cycle is mostly unaffected.

The strength degradation is extremely consistent during the five tests with an average of 15% reduction in capacity at the last, third step. Here, the stabilisation of the degradation effect can also be observed to occur after approximately 30 cycles within the steps, a value that was chosen precisely for this reason. The ultimate capacity of most samples is also consistent, with an average of 32 kN and a standard deviation of

1.9 kN. In spite of the remarkably consistent tests, specimen D showed some dissimilitude: first, the residual plastic deformation was significantly higher than in the other tests; second, the plastic displacement of the first step was negligible, almost zero; and third, the cycles of the last step had a higher strength than the previous cycles

(see erratic behaviour of force peaks, right in Fig. 10). It has not been possible to find a sensible explanation for this behaviour, albeit an out-of-plane influence cannot be neglected in this case.

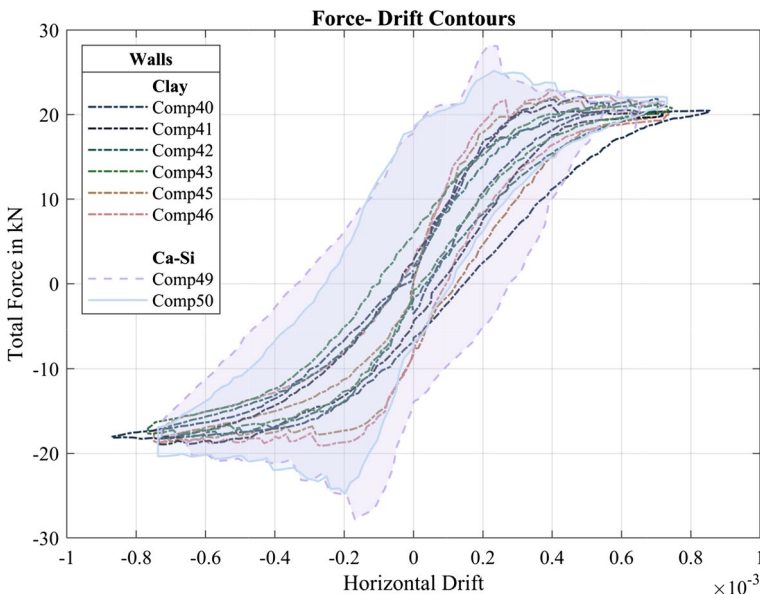
Fig. 11 Comparison of absolute envelopes (contours) between similar clay walls (dash-dotted) and the two calcium-silicate walls (shaded areas)

The two calcium-silicate walls were stiffer and stronger than all of their clay counterparts: This is visible in Fig. 11, where the absolute envelopes (positive and negative loading) of all the cyclic test results for all the tested walls are drawn (though only the area delimited by the CaSi walls is shown shaded for easier identification). The part of the envelope produced by the first step of the calcium-silicate walls is noticeably stiffer than the clay specimens, see peaks of shaded envelope area. Moreover, the calcium walls are stronger in both positive and negative directions. Nonetheless, the calcium-silicate walls experienced more damage at similar drift-values; this is particularly evident by the larger area contoured by the envelopes, indicating a higher hysteresis energy. This is also related to the total cyclic degradation which is higher for the calcium-silicate walls. Yet, the strength degradation during each step, as depicted by the jagged drops in the curves, is comparable for both clay and calcium-silicate specimens.

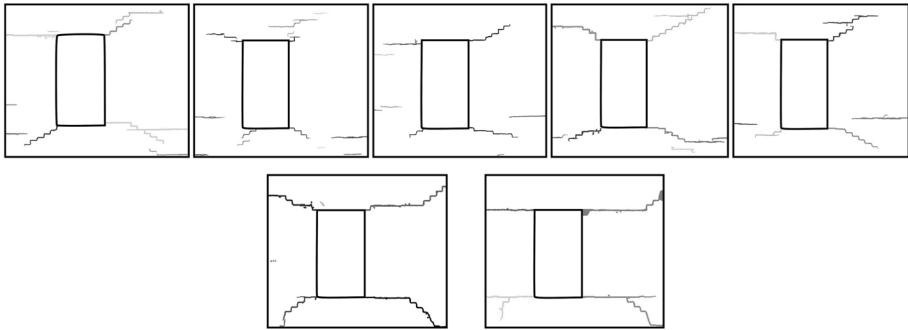
Fig. 12 Comparison of cumulative crack patterns between 5 clay walls (top) and 2 Ca–Si specimens (bottom). This is a summary of all cracks detected throughout the tests

The increased damage of calcium-silicate walls is also observable in the crack patterns of these specimens when compared to the clay walls. Figure 12 shows five clay walls where cracks are spread into a larger number of individual cracks, and follow predominantly diagonal patterns of off the window corners. Figure 12 displays a cumulative summary of all cracks throughout the entire tests, hence, in contrast, the two calcium-silicate walls display only four cracks which propagate first horizontally from the window corners, then diagonally, and later run vertically through the bricks. The splitting of bricks was something only observed in the calcium-silicate specimens. In fact, spandrel tests, which were to mimic a vertical crack underneath the window bank of the walls, also displayed no brick-splitting in the clay material, but did allow for this brittle failure mechanism in the calcium-silicate specimens. Figure 13 shows that the vertical crack in CaSi spandrel

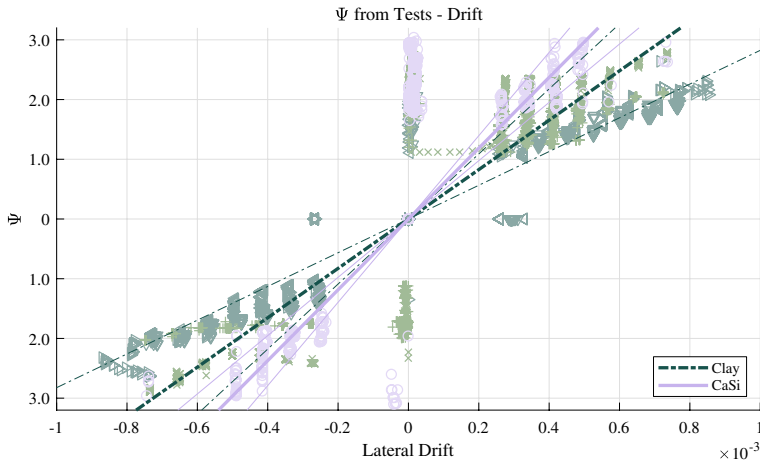
Fig. 14 Linear regression of the relationship between (non-zero) drift and damage measured in Ψ for clay and calcium-silicate (CaSi) walls at zero, positive and negative drift values for each cycle. Thinner lines show one standard deviation. Circles show CaSi data while angular shapes show clay data

The higher sensitivity to damage of this type of calcium-silicate masonry is further expressed in Fig. 14, where the damage values, as computed with the Ψ parameter, are shown for numerous values of drift. The maximum value of Ψ is computed for each cycle

at the zero position and positive and negative directions (see also Fig. 6). First, in Fig. 14, the values corresponding to calcium-silicate walls reach values higher than any of the clay walls. Moreover, residual damage (at or close to zero drift) also displays a larger value of Ψ . Furthermore, a linear regression using the Theil–Sen method of slope fitting (Theil 1950) is produced for all the non-zero data. This fit does not consider that walls are progressively damaged during the cyclic steps; yet, it is clear that calcium-silicate walls have a steeper drift-damage relationship. If the range of $1 < \Psi < 3$ is considered as DS1 (Korswagen et al. 2019), damage starts to be detectable at drift values of 0.25‰ and corresponds to DS1 until 1.1‰ for the clay walls, while, for the calcium-silicate cases, DS1 appeared already at values between 0.15 and 0.65‰. These values consider the one-standard deviation shown.

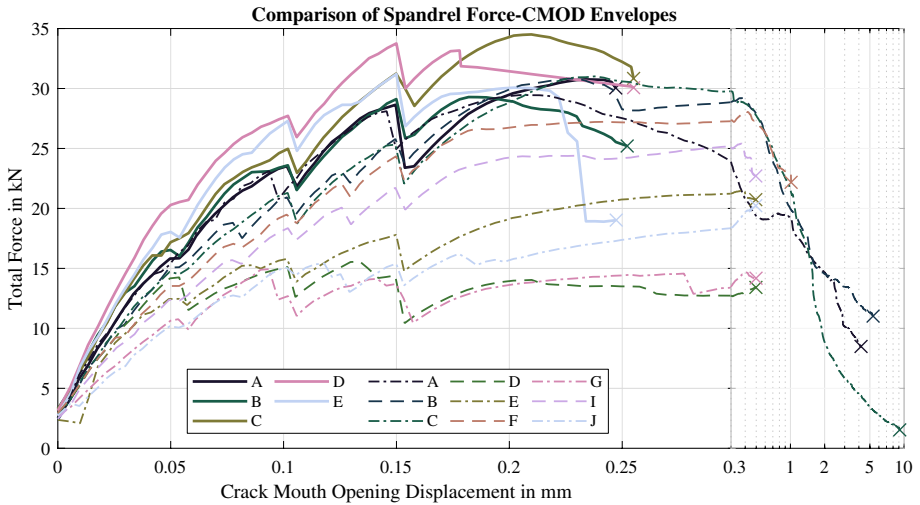
Fig. 15 Comparison of force–displacement (CMOD) envelopes between spandrel tests of calcium-silicate brick (solid lines) and clay brick (interrupted lines) masonry

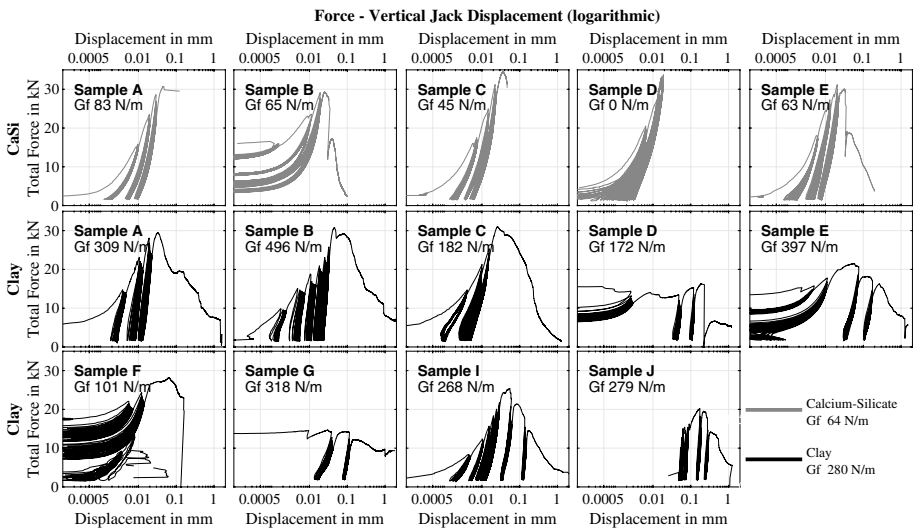
Fig. 16 Force-displacement (vertical at jacks, not CMOD) for spandrels showing the interpreted tension fracture energy (G_{II})

The flexural strength of the masonry composite material can be computed from the spandrel tests in a way similar to the standard four-point bending test. Here, calcium-silicate samples average a value of 0.6 MPa with a variation of 7%, while their clay counterparts reach 0.5 MPa in average with a variation of 24%. This difference in strength and the fact that calcium-silicate spandrels are also stiffer can be observed in Fig. 15 where the envelopes of the force-CMOD as presented in Fig. 10 are compared to the previously tested clay specimens. Yet, the strongest observation is that calcium-silicate specimens are significantly more brittle than the clay ones. All calcium-silicate specimens reached (sudden) failure at approximately 0.25 mm of crack width, while some clay samples could be tested up to 5 mm of crack width, way beyond DS1 (note that some clay tests were purposely stopped at 0.5 mm). If the vertical crack produced by the spandrel tests belongs to the window bank (ground floor spandrel) of a structure, the calcium-silicate material would be more vulnerable to exceeding DS1. This had also been qualitatively shown in Fig. 13. Furthermore, in Fig. 16, the total force is plotted against the average vertical displacement at the jacks, rather than the CMOD, which allows an estimation of the fracture energy of the tests. Assuming an idealised straight vertical crack with a length of 0.5 m and a thickness of 0.1 m, the energy input by the setup can be interpreted as the mode-I tensile fracture energy (G_{I}) of the composite

material. This parameter can serve to further compare the materials. Here, neglecting sample D of the calcium-silicate tests which reached failure early on, the average of the clay spandrels is 4 times higher than the value of 64 N m^2 calculated from the calcium-silicate tests (see Table 3 for a summary). This confirms the more brittle behaviour of this type of calcium-silicate brick masonry in comparison to the replicated clay brick masonry of this study. The larger value for clay is possibly due to the sliding and
