## A pragmatic, performance-based approach to levee safety assessments

Rikkert, Stephan Johannes Hendrikus; Kok, Matthijs; Lendering, Kasper; Jongejan, Ruben

Journal of Flood Risk Management

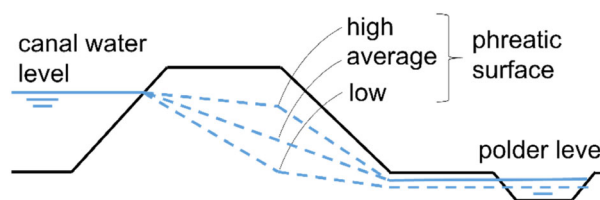
FIGURE 1 Schematic representation of possible phreatic surface levels (high, average, and low)

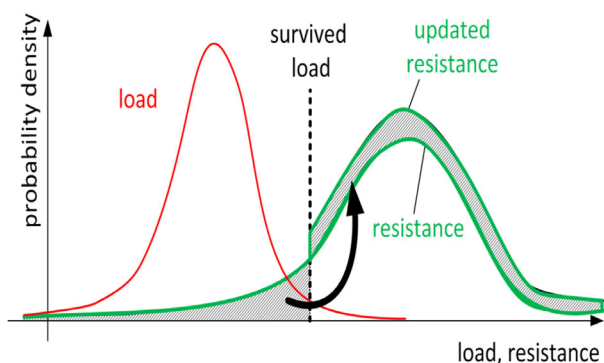
FIGURE 2 The concept of “reliability updating,” where the probability density under the survived load is redistributed over the probability density above the survived load (Schweckendiek, 2014)

In which  $P(F|\epsilon)$  is the probability of failure, given observation  $\epsilon$ . This is illustrated in Figure 2: the failure probability is determined by the probability density of the load (in red) and the probability density of the resistance (in green). When the levee resistance is constant in time, a survived load (at dashed vertical black line) serves as evidence that the probability of failure for that load (and smaller loads) equals zero. The probability density under that load is then redistributed over the probability density above that survived load, reducing the levee’s overall failure probability.

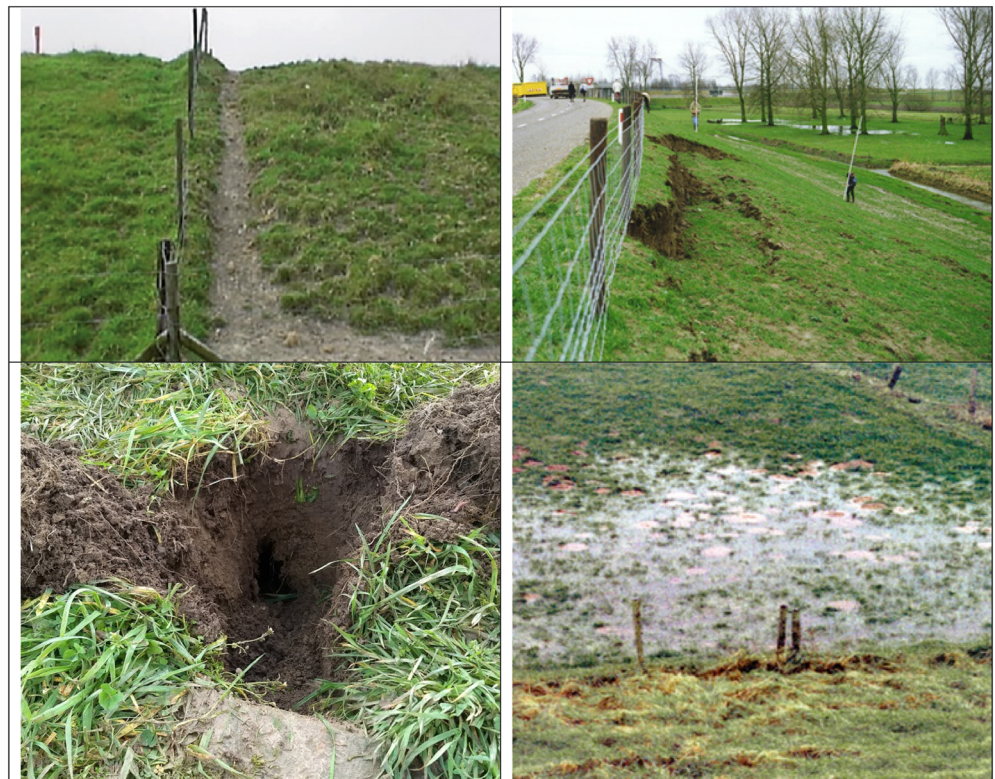
**FIGURE 3** Examples of performance indicators. Local subsidence due to trampling by livestock (upper left; picture from STOWA, 2018), severe subsidence (upper right; picture from STOWA, 2018), animal burrowing (lower left, picture taken by S.J.H.Rikkert, 2020), and wet spots at the levee toe (lower right; picture from STOWA, 2018)

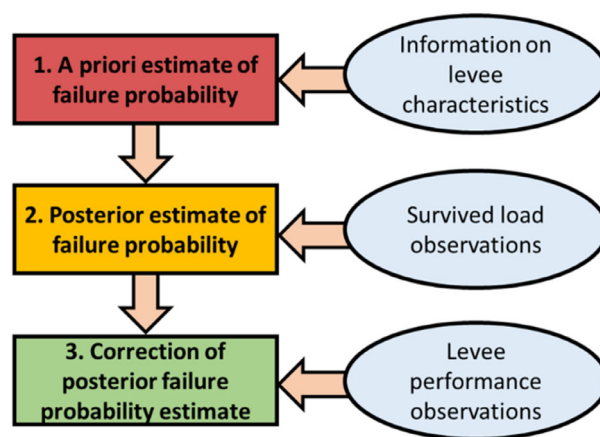
FIGURE 4 Schematization of the proposed method to estimate the failure probability, utilizing information on levee performance under critical conditions and levee inspection results

Figure 4 shows a schematization of the proposed approach. The first step of this method is to estimate the failure probability, based on levee specific load and strength parameters. In the two following steps, this estimation is improved by including observed levee behavior.

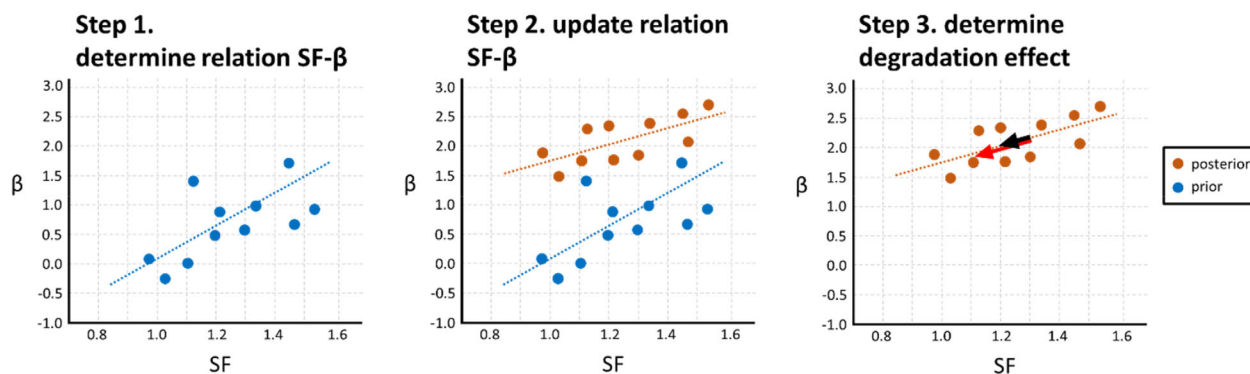
**FIGURE 5** The approach explained through three steps. Step 1: Relation between safety factor SF and reliability index  $\beta$  for one levee type, based on probabilistic stability assessments. Step 2: Updating the prior relation between safety factor SF and reliability index  $\beta$  for one levee type, based on observations of survived hydraulic loads, with the prior relation in blue and the relation after updating in orange. Step 3: The arrows indicates how different degrees of degradation (black: light degradation; red: severe degradation) affect the stability factor, and hence the reliability index, of one levee type is influenced by levee degradation. The arrows are indicative, and effects on the stability factor depend on levee characteristics and degradation type

2. Observations of performance of the levee under various loading conditions can be included, using the approach described in Section 2.2.1 on reliability updating. The initial relation found in step 1 can be improved, by fitting a line through the points after reliability updating, as is shown in (see step 2 in Figure 5).

3. The final step is to correct the posterior failure probability by including results of levee inspections in the form of levee performance indicators, in addition to the survived loads from the previous step. These levee performance indicators contain information about the actual condition of the levee, and they influence the stability factor, and hence the probability of failure. Ideally, the same approach as in step 2 would be used here: including the effects of a certain performance observation, based on Bayes theorem. However, in this study a more pragmatic approach was used to limit the processing time of the study. Besides, discretization of the load and resistance in reliability updating makes it difficult to take into account gradual degradation. Therefore, we assumed that the effect of an observation (e.g., animal burrows) on the stability factor can be expressed as a reduction factor that is dependent of the levee type, the performance indicator and the level of severeness (see step 3 in Figure 5).

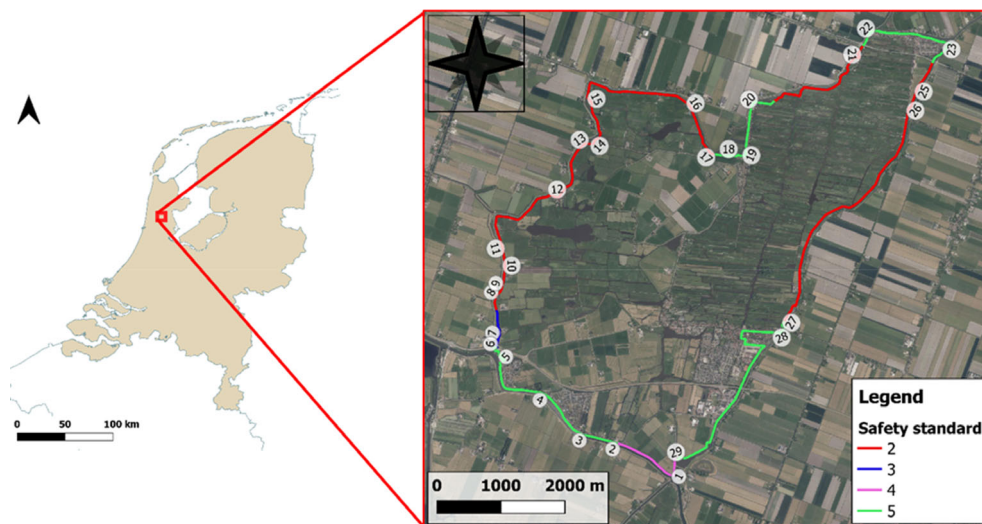
**FIGURE 6** Left: Map of the Netherlands, with the location of the Eilandspolder. Right: Overview of levees protecting the Eilandspolder, the distinction into separate, numbered, levee sections, and their assigned flood protection standard

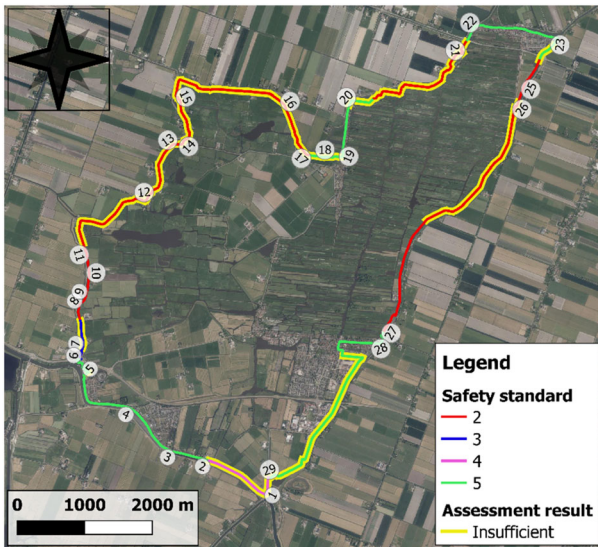
FIGURE 7 Overview of levees that do not meet the required safety standard for the failure mechanism macro-instability

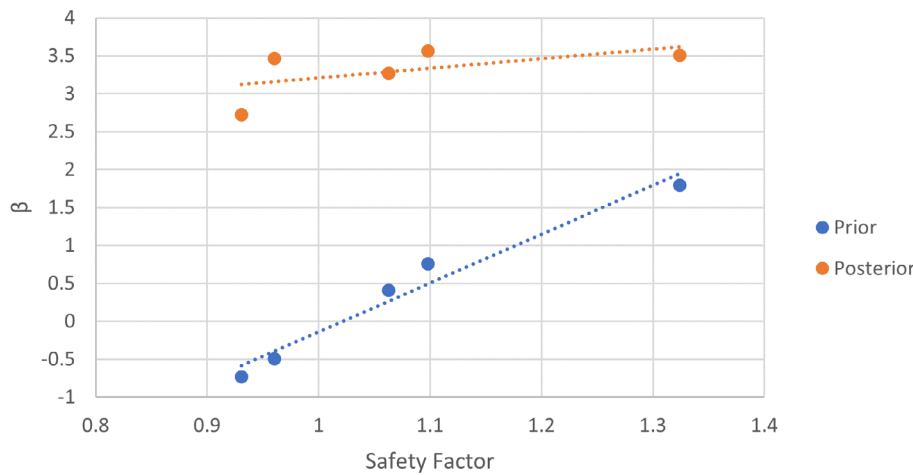
FIGURE 8 Results of probabilistic stability assessment for a-priori (blue) calculations and after reliability updating (orange)

Figure 8 shows the results of the stability analysis before and after reliability updating. As the figure shows, including observations of survived loads result significantly increase the estimated reliability index. The new Safety Factor and reliability index were found by assuming a failure probability of 0 during the survived load combinations.

The relation between  $\beta$  and SF after reliability updating shows a different, milder, slope than before updating, as can be seen in Figure 8. A possible explanation for this change in slope is that reliability updating might have a larger effect on stability assessments that resulted in low safety factors (low values for  $\beta$ ), than on high safety factors, especially if the lower safety factors are caused by high uncertainties. Observations of survived loads will then result in a large uncertainty decrease and, consecutively, in higher reliability indices. If uncertainties are smaller, reliability updating is expected to have a smaller effect, resulting in a decreased slope.

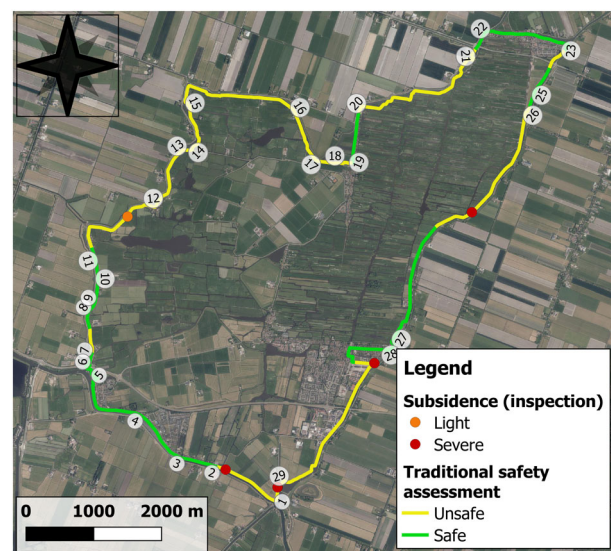
FIGURE 9 Map showing the subsidence observations from the levee inspection. Light subsidence is observed in section 4.5, and severe subsidence is observed in section 1 (on 2 locations), 8.2, and 9.2

Figure 9 shows the severity of levee subsidence per location, observed during levee inspections over a course of about 2 years (2016–2018). The figure only includes observations of levees that were unsafe according to the semi-probabilistic safety assessment. A distinction is made based on the degree of severity of subsidence:

- Light subsidence: about 0.25 m subsidence is observed in section 12;

- Severe subsidence: about 0.5 m subsidence is observed in section 1, 26, and 29.
